No. : AV.15013/5/2008/AS

**ON ACCIDENT TO PUNJAB GOVERNMENT KING AIR C-90
AIRCRAFT VT-EHY AT VILLAGE JUGIANA NEAR
SAHNEWAL AIRPORT LUDHIANA ON 29.10.08**

**AIR SAFETY DIRECTORATE
O/o DIRECTOR GENERAL OF CIVIL AVIATION
OPP. SAFDARJUNG AIRPORT, NEW DELHI**

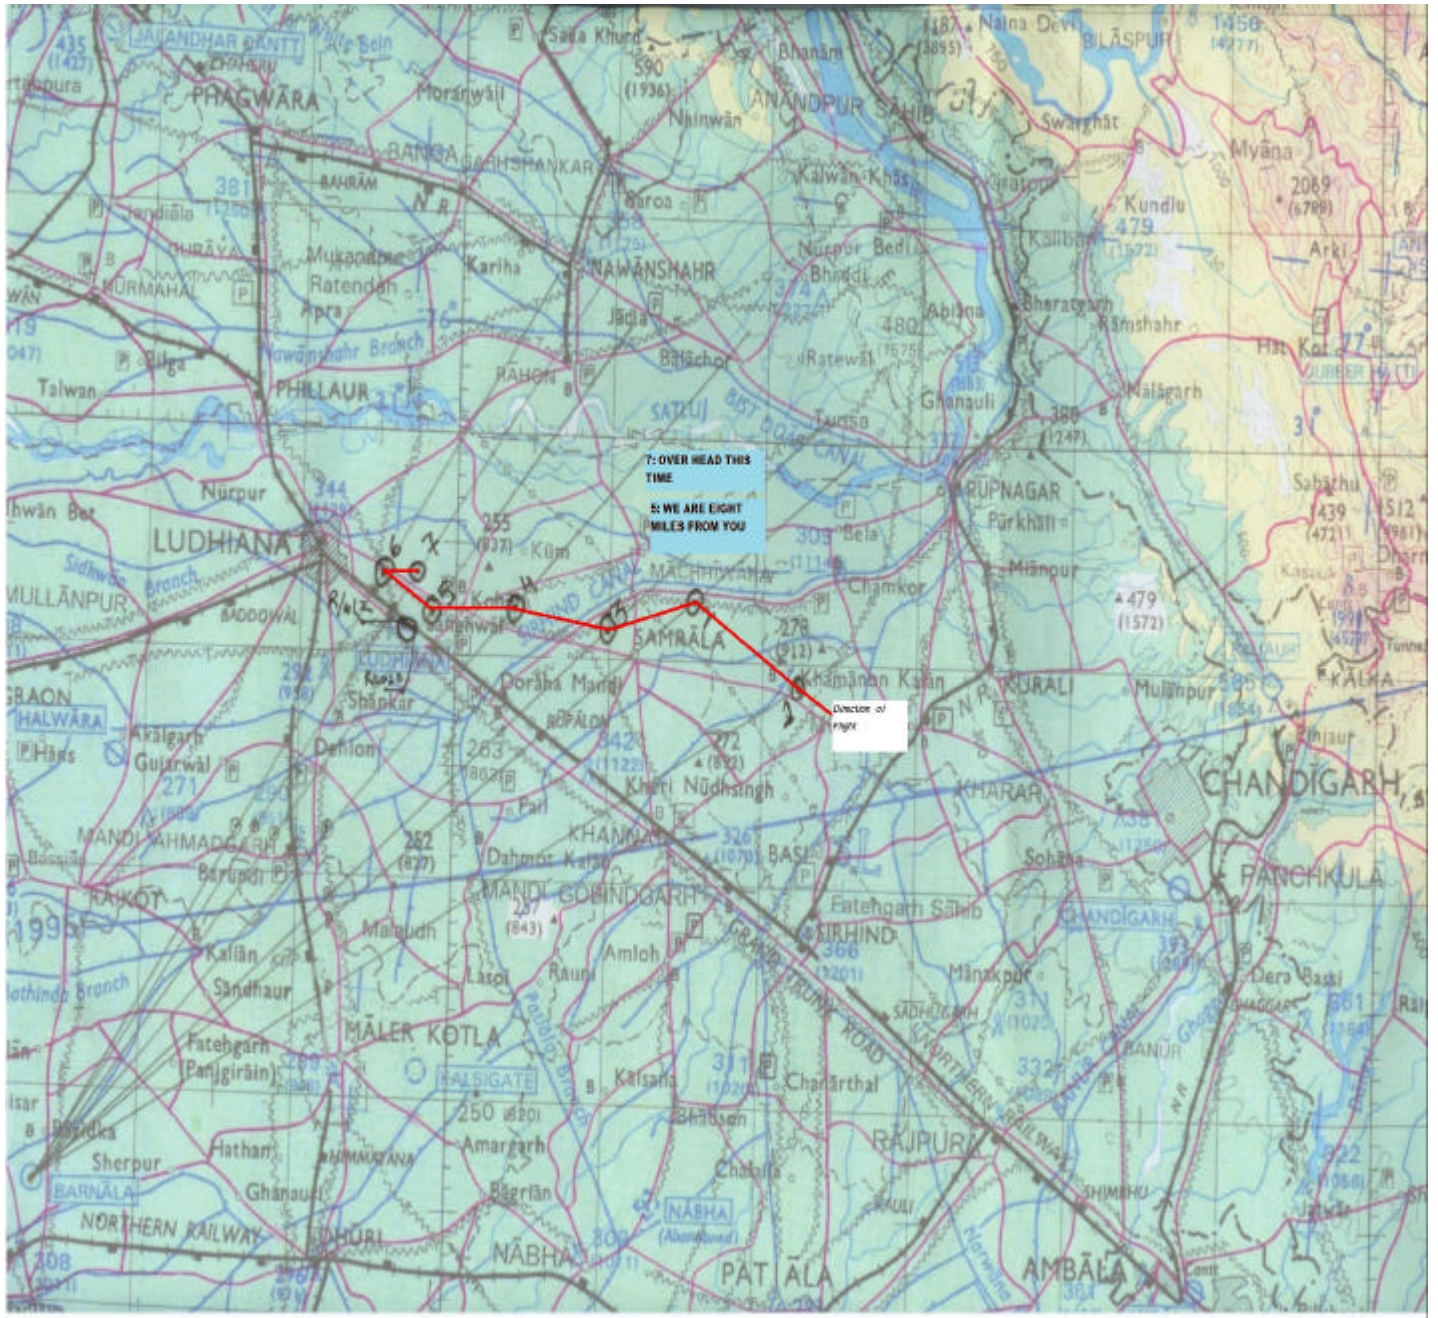
1.12.5 **Correlation of Radar Plot and Radio Communication**

At 11:10:31 hrs. aircraft turned left for Ludhiana. At 11:15:30 hrs. it flew abeam R/w 30 towards R/W12 when crew reported to Ludhiana and subsequently informed that they were eight miles and at 7000 ft to 6000 ft and requested descent clearance. At 11:17 hrs. it commenced right hand turn after crossing T/H R/W 12 and subsequently requested for R/w in use. At 11:19 hrs. while it was in right hand turn it reported overhead this time. Thereafter at 11:22 hrs. it reported 2 miles from the R/w and at 11:23 hrs. the aircraft reported over the field and informed that it will make a circle to land on R/W 12. Apparently, the aircraft approached R/W12 from right.
