**GOVERNMENT OF INDIA
MINISTRY OF CIVIL AVIATION**

**FINAL INVESTIGATION REPORT ON ACCIDENT
TO AIR INDIA AIRBUS A-320 AIRCRAFT VT-ESH
AT JAIPUR ON 05.01.2014**

**AIRCRAFT ACCIDENT INVESTIGATION BUREAU
SAFDARJUNG AIRPORT
NEW DELHI – 110003**

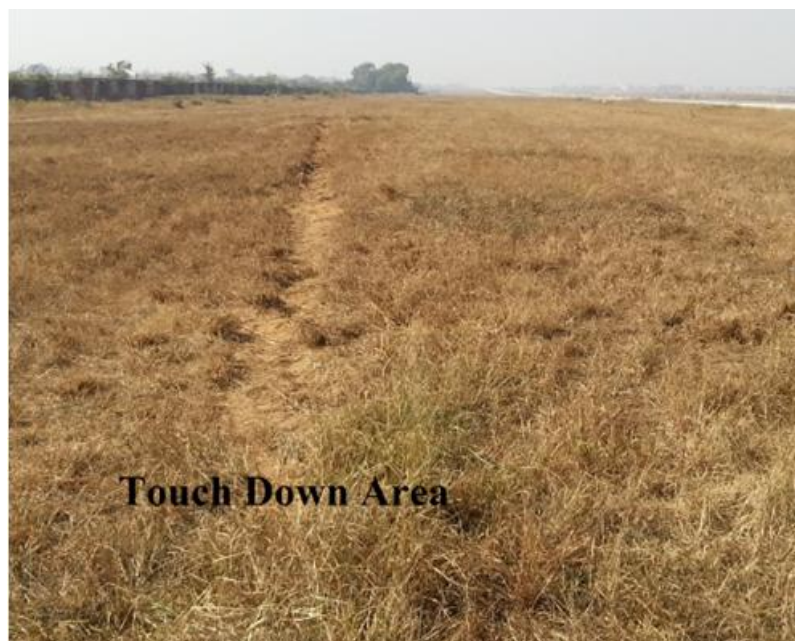
Left main wheel rolled over the drain boundary area

The aircraft continued to roll/ skid on the unpaved surface and during this period the left wing impacted trees causing damage to the left wing. Thereafter aircraft turned right and entered the runway finally coming to a halt on the LH side of runway. There was no fire.

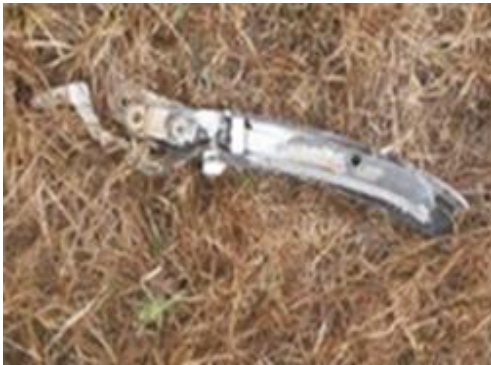
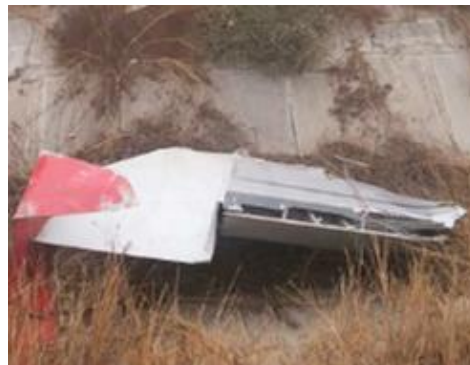
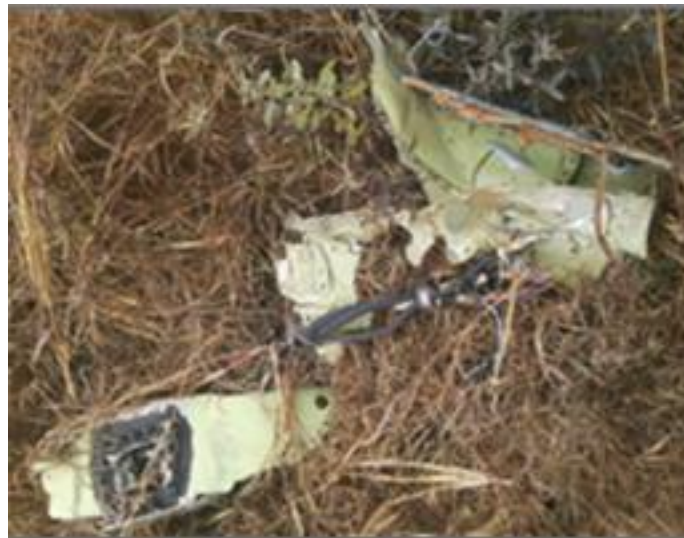
Thereafter the aircraft turned right but at the same time hit trees wherein the left wing leading edge structure got damaged from rib 23 onwards. Outboard wing spar box including upper skin, lower skin, front spar, rear spar and ribs got sheared off from a distance of about 5 ft from the wing tip.

- Wing leading edge structure was found damaged from rib 23 onwards.
- Slat wing tip brake and hydraulic lines damaged at front spar.
- Rear spar sheared from rib 25.
- Upper flange of rear spar cracked outboard from rib #24.
- 1/3rd portion of aileron outboard area sheared off.
- Left outboard flap damaged near outboard tip lower surface.
- Aileron upper and lower access panels damaged.
- Wire bundle on front spar pulled/damaged/snapped outboard of rib #23.
- No. 1 main wheel found decapped.
- Observed multiple cuts and rubs on main wheel #5.
- Grass straws observed on fan blades of both the engines.
- Blue system loss due hydraulic line ruptured in slat 5 area.
