FINAL INVESTIGATION REPORT
ON ACCIDENT TO
JET AIRWAYS BOEING B-737-800 AIRCRAFT VT- JBG
AT GOA ON 27.12.2016

Rajinder Singh Passi
Chairman, Committee of Inquiry

FINAL INVESTIGATION REPORT ON ACCIDENT TO JET AIRWAYS
BOEING B-737-800 AIRCRAFT VT- JBG AT GOA ON 27.12.2016

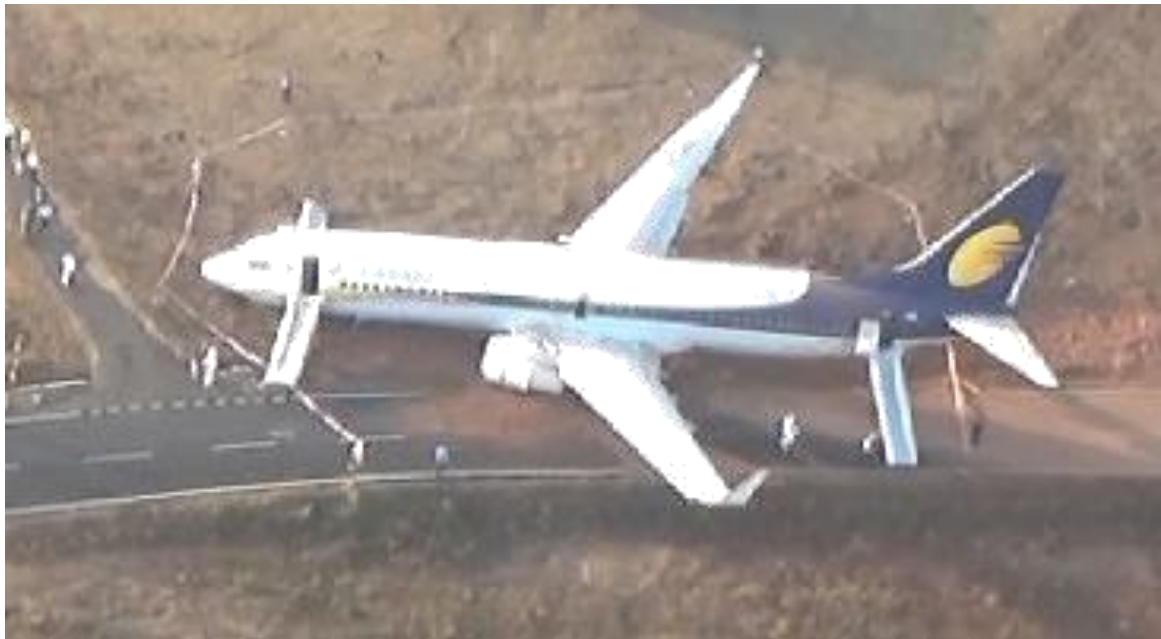
FINAL POSITION OF THE AIRCRAFT

At 22:39 UTC crew informed ATC of having evacuated all passengers. L1, L2, R1 and R2 cabin crew evacuated after evacuating all passengers, taking along the safety and medical kits. Co-pilot and subsequently Captain also evacuated the aircraft.

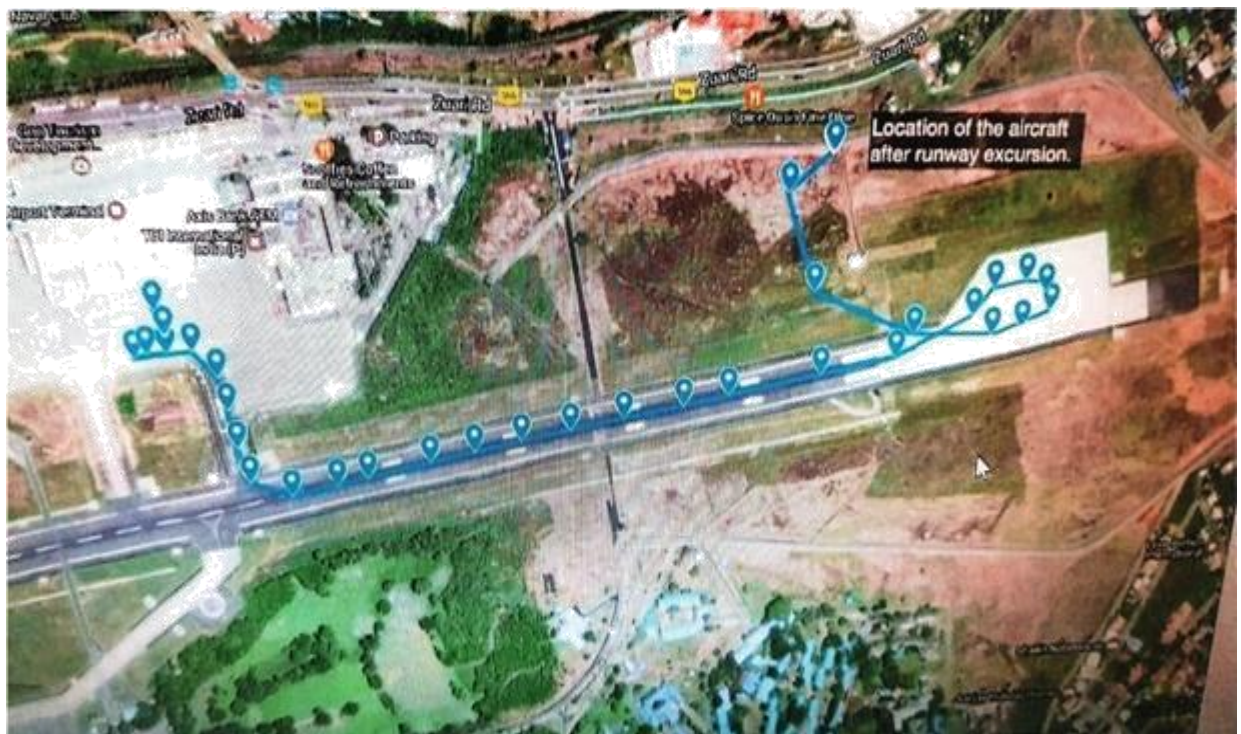
1.12 Wreckage and impact information

The crew could not control the aircraft and it went into kutchra. The aircraft stopped at a distance of approximately 219 m from the Rwy centre-line, just short of periphery road. There were some unused RVR observation vertical cement pillars of approx 2.3 m height in the path traversed by the aircraft. Though the aircraft stopped and the wreckage was self contained, there were following structural damages due high speed travel on the undulated ground
