**FINAL REPORT OF ACCIDENT
INVOLVING
M/s JET AIRWAYS ATR 72-600 AIRCRAFT
VT-JCX
AT INDORE
ON 07TH MAY 2016**

FINAL REPORT ON ACCIDENT TO M/s JETAIRWAYS ATR 72-600

AIRCRAFT VT-JCX AT INDORE ON 07/05/2016

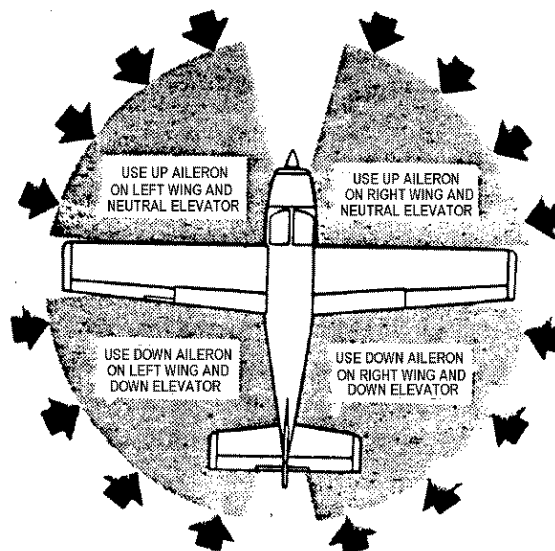
Fig 12

At lower speeds the nose down input helps in increasing directional stability by applying higher load on nose wheel if using nose wheel steering. The figure above depicts use of controls in different wind conditions.

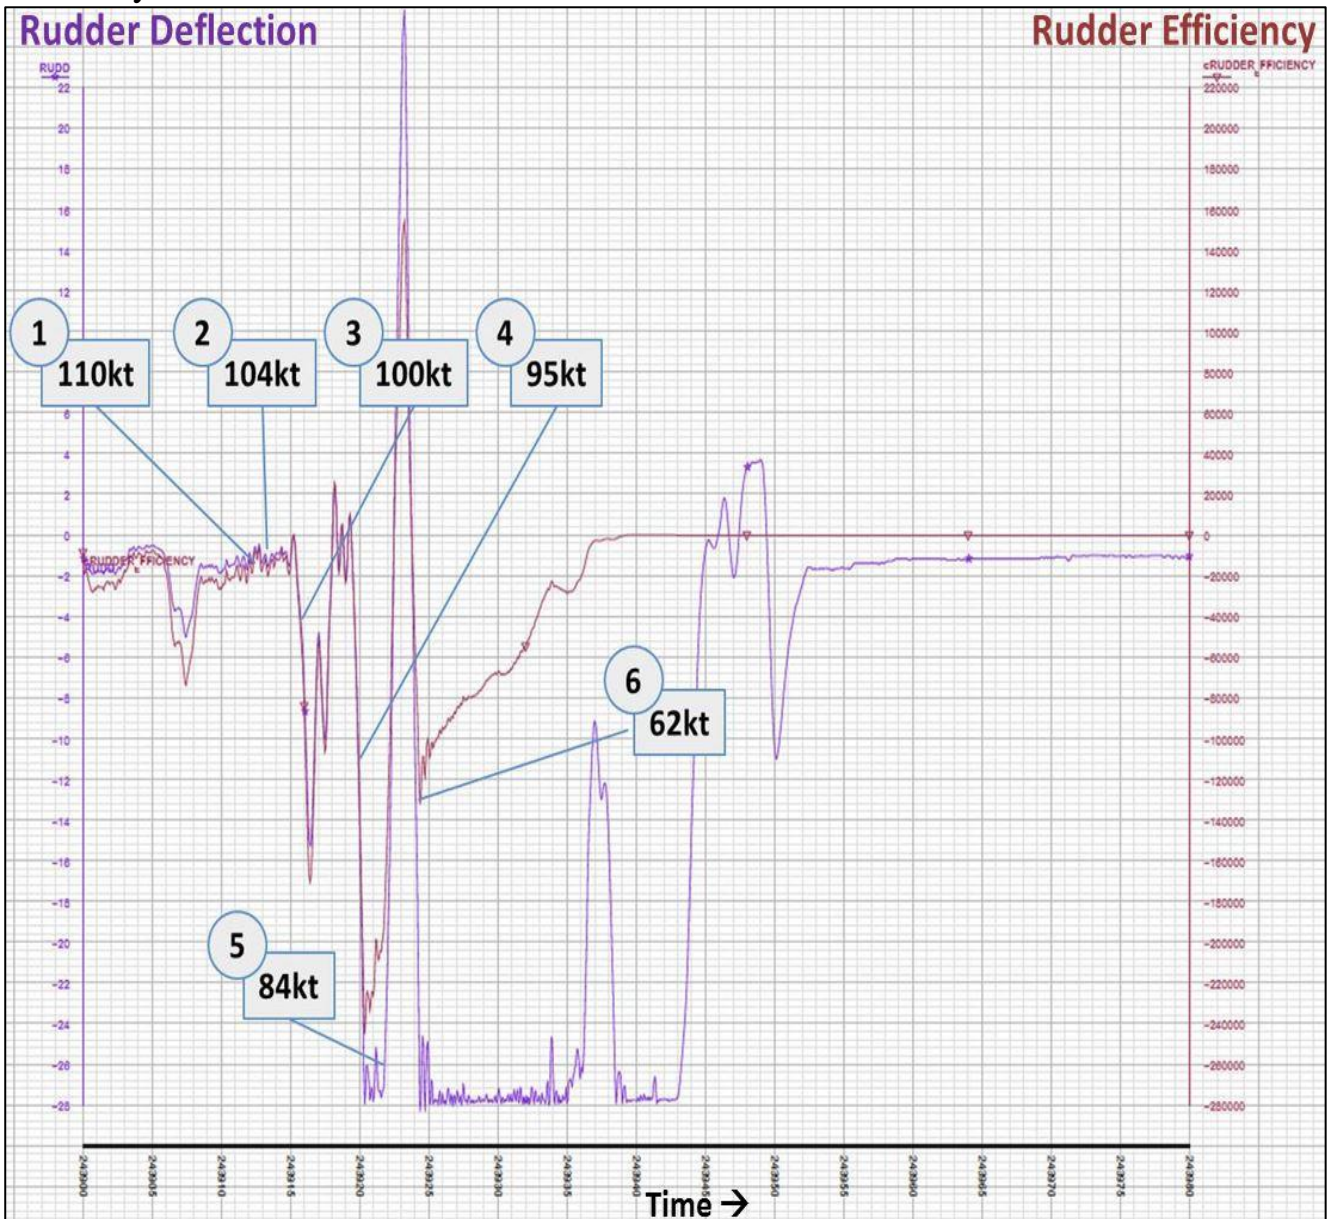
Fig 13

The aerodynamic efficiency of the flight control surfaces such as rudder is related to with square of the speed and proportional to deflection; the graph below is plotted using data from the DFDR and represents the rudder deflections efficiency as a function of time during the event sequence. With the same deflection, the efficiency of the rudder between the first rudder deflection at 95Kt and the second at 62Kt, in 7 seconds, has been reduced by more than half. Below 60Kt the rudder efficiency drops quickly to null efficiency.

In addition, the graph attached also shows the effort applied on the rudder pedals, the diminution of the effort to maintain the mechanical stop of the rudder illustrates the rudder's decreasing effectiveness from the reducing force needed on the rudder pedals.
