**INVESTIGATION REPORT ON ACCIDENT TO  
AGUSTA AW 119 MK II HELICOPTER  
VT- NRK ON 10-06-2017  
AT  
BADRINATH JI HELIPAD, UTTARAKHAND.**

**GOVERNMENT OF INDIA  
MINISTRY OF CIVIL AVIATION  
AIRCRAFT ACCIDENT INVESTIGATION BUREAU**

**Final Investigation Report on accident to M/s Kestrel Aviation Pvt. Ltd. Agusta  
AW119 MK II Helicopter VT-NRK Near Badrinathji Helipad on 10.06.2017**

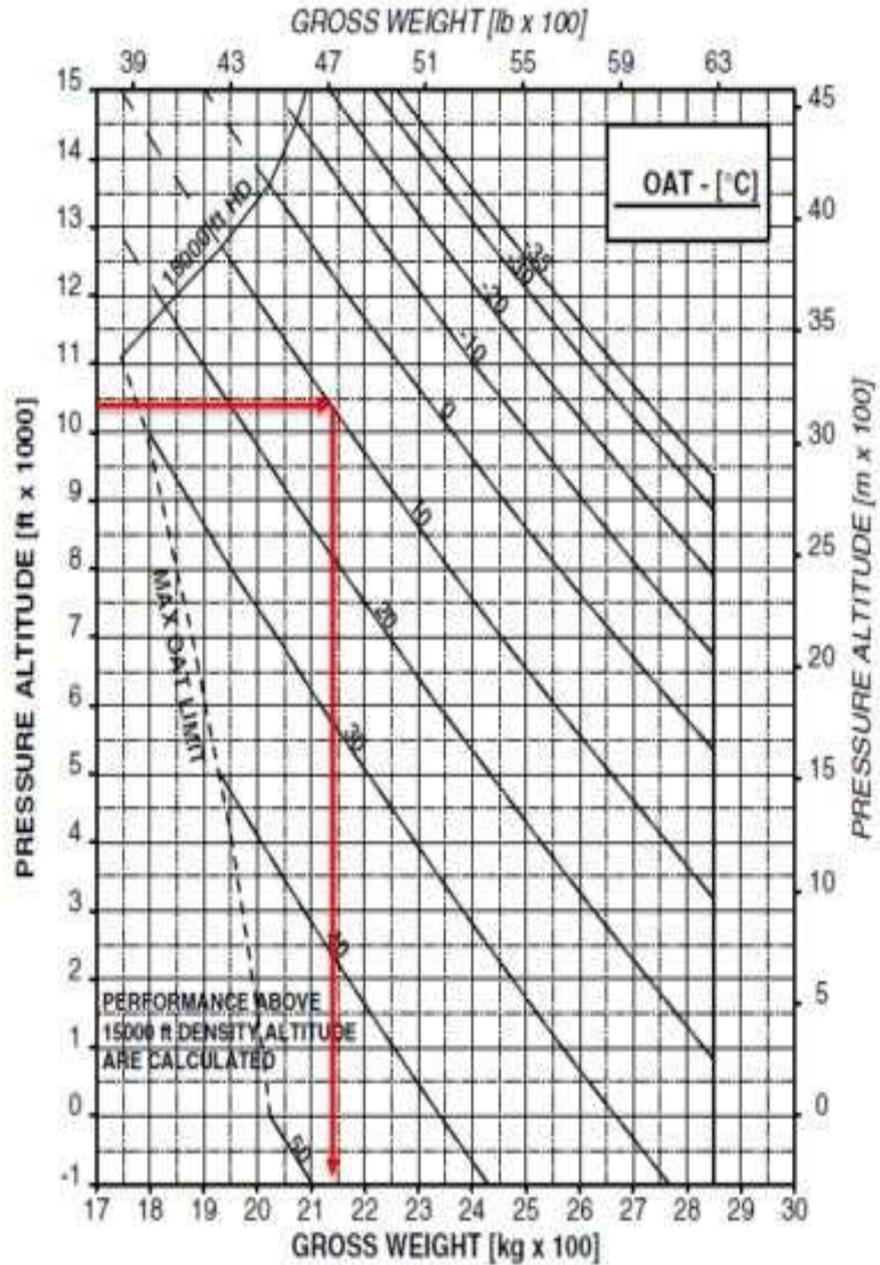
As per the Load & Trim Sheet, the estimated AUW of the helicopter at the time of take-off was 2681 kgs. As per the PF, they had performed a “Hover check” prior to leaving the Helipad, which if the take-off power was being used under HIGE conditions gives a maximum AUW of 2710 kgs. The AUW was therefore within limits.

According to the above calculations, though the capability of the helicopter was within limits (HIGE / TOP) but marginal. Helicopter would not have been able to perform under HOGE conditions using Take-Off Power (TOP) in the reported conditions.

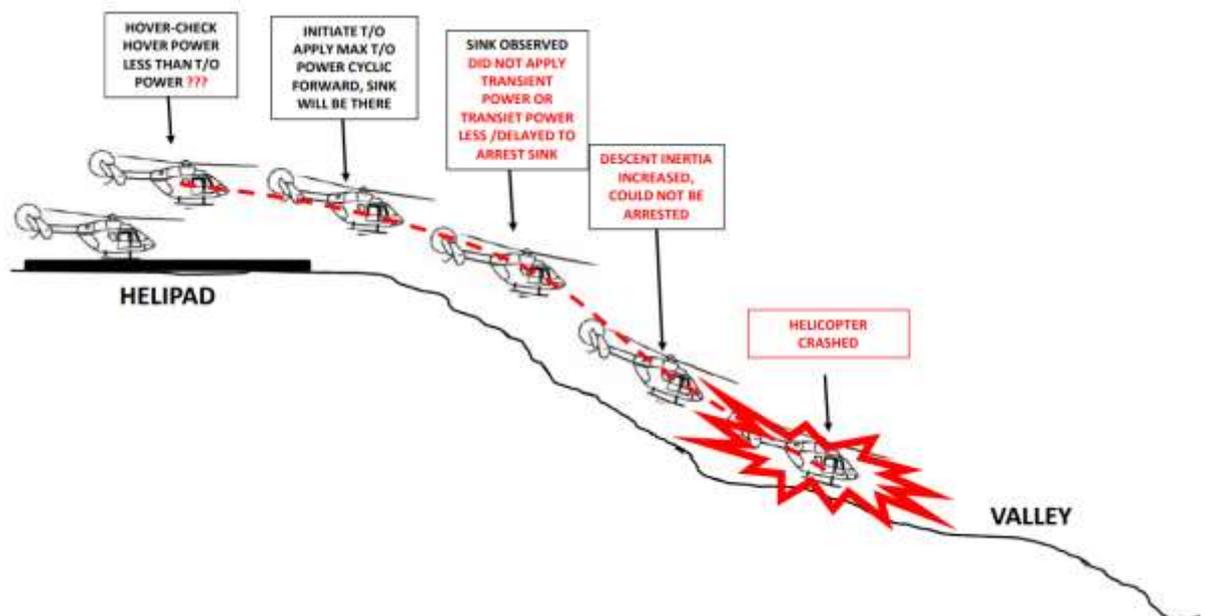
Since the pilot had commenced takeoff from the closest front edge of the ledge helipad towards Joshimath, soon after takeoff the helicopter encountered HOGE conditions. As soon as the helicopter encountered HOGE conditions from HIGE conditions, with almost full pay load, the PF felt natural sink which he tried to arrest by raising the collective. Unable to arrest the sink and being aware of the cables which he thought might obstruct his path; he tried to put the helicopter on ground in front of him by lowering the collective.

On lowering the collective, the helicopter yawed to the left. The right rudder correction probably was more than required, which consumed power and the helicopter turned towards right by around 60-70 degrees from its flight path. Finally the helicopter impacted the ground below the electric cables which converge with the following flight path.
