**FINAL INVESTIGATION REPORT ON ACCIDENT
TO AMAN AVIATION & AEROSPACE
SOLUTIONS (P) LTD.**

**ROBINSON R-44 HELICOPTER VT-PHB
ON 11-12-2016 NEAR JUHU, MUMBAI**

**AIRCRAFT ACCIDENT INVESTIGATION BUREAU
MINISTRY OF CIVIL AVIATION
GOVERNMENT OF INDIA**

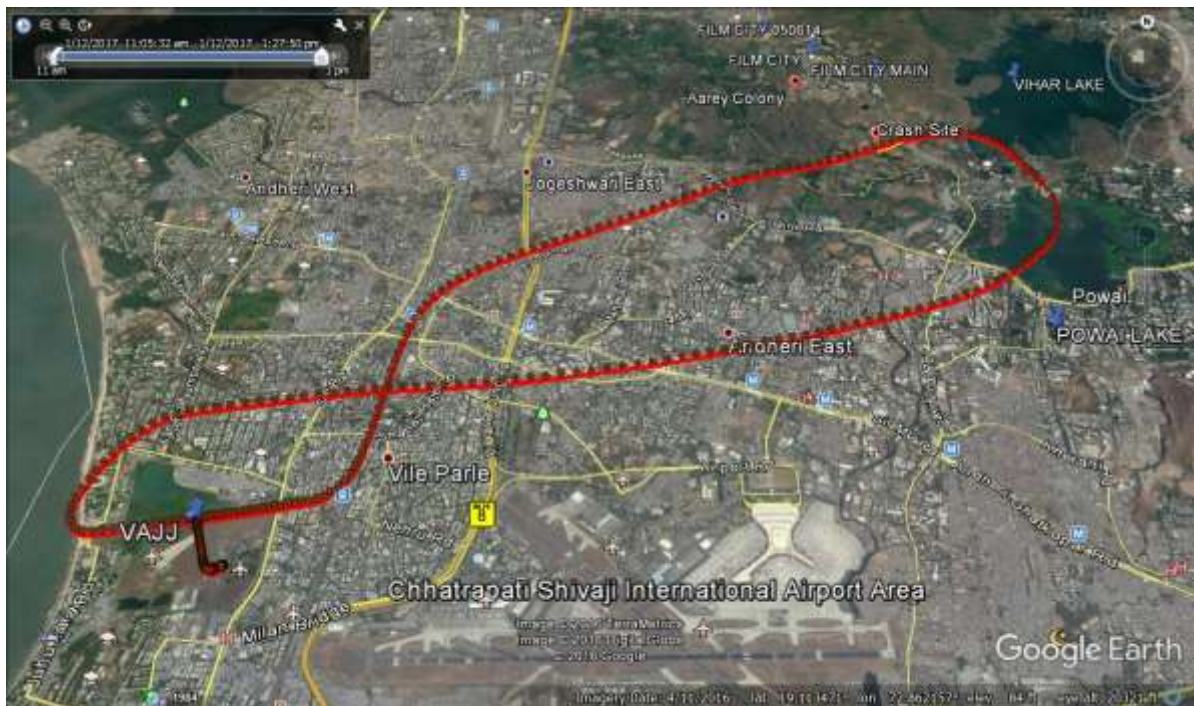
The helicopter took off from Juhu airport for Mumbai sightseeing. In front, along with captain there was a technician and in rear there were two passengers. This was the second flight of the day and no abnormality was reported during the first flight. The normal flight path followed by the helicopter for such flights was followed on that day as below:

During sightseeing helicopter maintains 500ft AGL throughout the sortie to enable passengers to have a closer look of the area below. After crossing Powai lake this helicopter took a left turn to fly over parts of Vihar lake and turned back towards Juhu. Close to Aarey colony the pilot gave a call to Juhu ATC "Juhu,

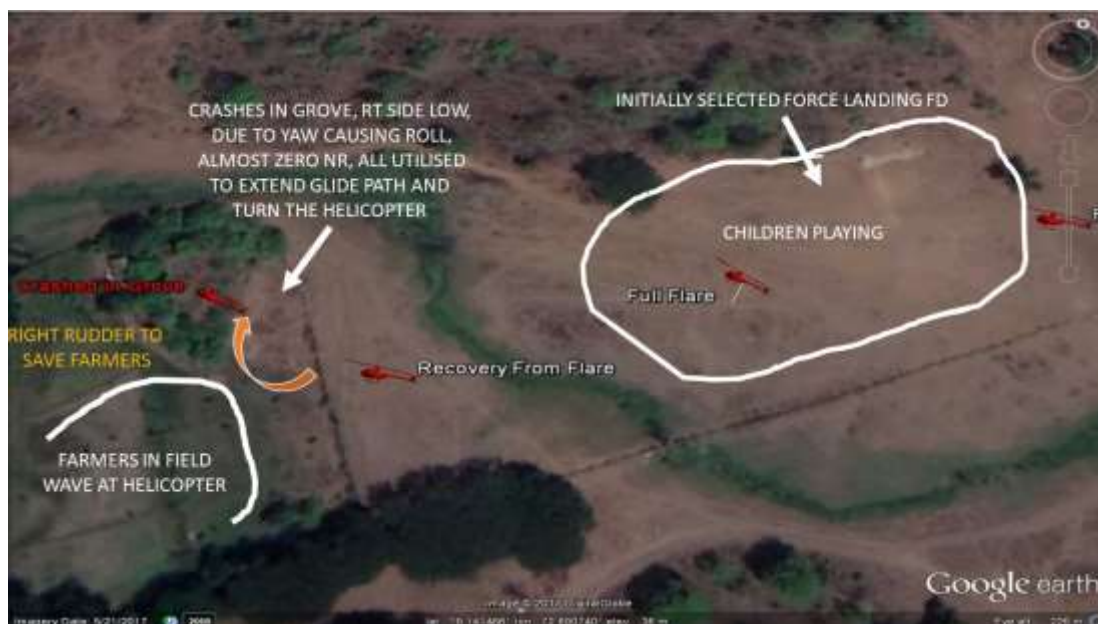
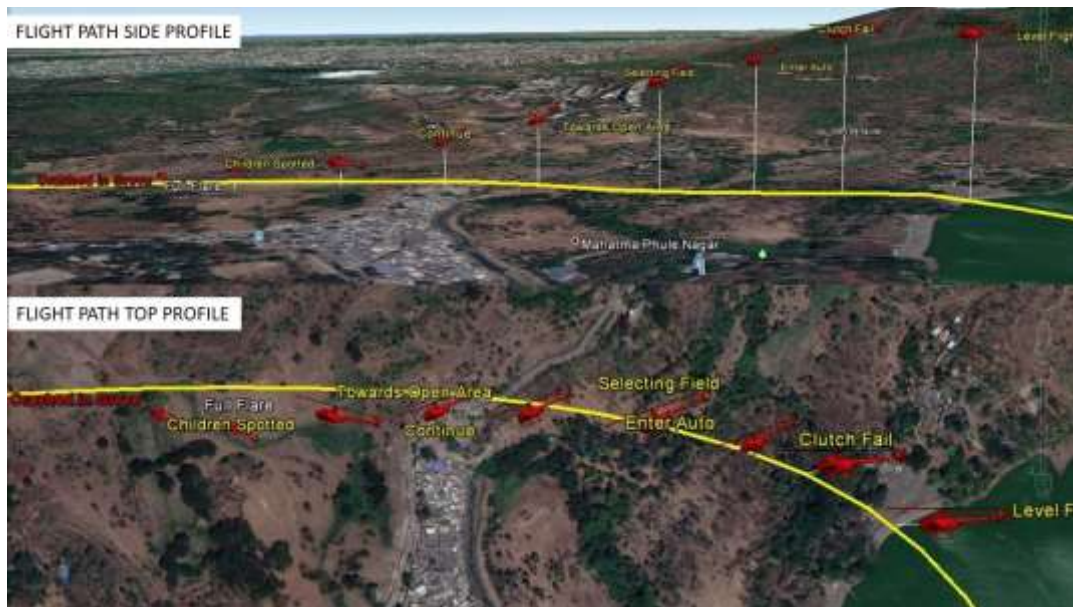
The pilot had put the helicopter in proper autorotation and selected a force landing field which was clear of obstructions. During autorotation when the helicopter came close to the ground, PIC realised that there were children playing there. He stretched his glide path by using some collective input and proceeded further, in this process he must have lost some of his rotor RPM. While he was flaring he saw a few workers in the field where he would have landed, hence he carried out a right yaw to avoid landing his helicopter on those workers. This resulted in the helicopter side slipping and slight roll to the right into a grove of trees and bushes. To cushion the landing he had used his full collective which led to zero rotor RPM while impacting the trees/bushes/ground. This is evident from the fact that neither the main rotor or the tail rotor blade had any frontal impact marks, suggesting that during the autorotative process, all kinetic energy of the main rotor system generated due to auto-rotation was utilized during the flare and recovery of the helicopter.

Just prior to the impact, as the helicopter was yawing to the right, it got into further effect of right yaw and rolled towards the right. It made contact with the ground and tilted to the right, which led to impact loads on PIC and right rear passenger side. The technician who was sitting on the co-pilot seat (left side) was unhurt. As the engine was still running without giving power to the transmission system and helicopter, it caught fire on impact.
