**GOVERNMENT OF INDIA
MINISTRY OF CIVIL AVIATION
AIRCRAFT ACCIDENT INVESTIGATION BUREAU
NEW DELHI INDIA**

**REPORT ON
ACCIDENT TO M/s PAWAN HANS
DAUPHIN N3 HELICOPTER VT-PHK
AT KHONSA
ON 04/08/2015**

**REPORT ON
ACCIDENT TO DAUPHIN N3 HELICOPTER VT-PHK
NEAR KHONSA (ARUNACHAL PRADESH) ON 04/08/2015**

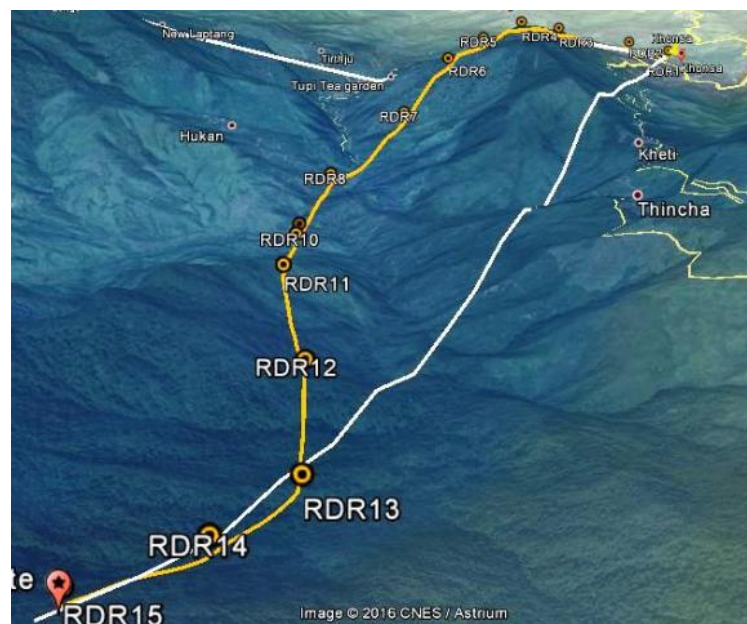
1.16.2 Flight track

Radar data of the accident flight was obtained though there was no audio provided in the recording. Various positions of the helicopter against time were taken and superimposed to have a track of the accident helicopter. The flight path of the helicopter from Khonsa to the crash site (15 different values based on the positions in the radar plot) was plotted as shown above.

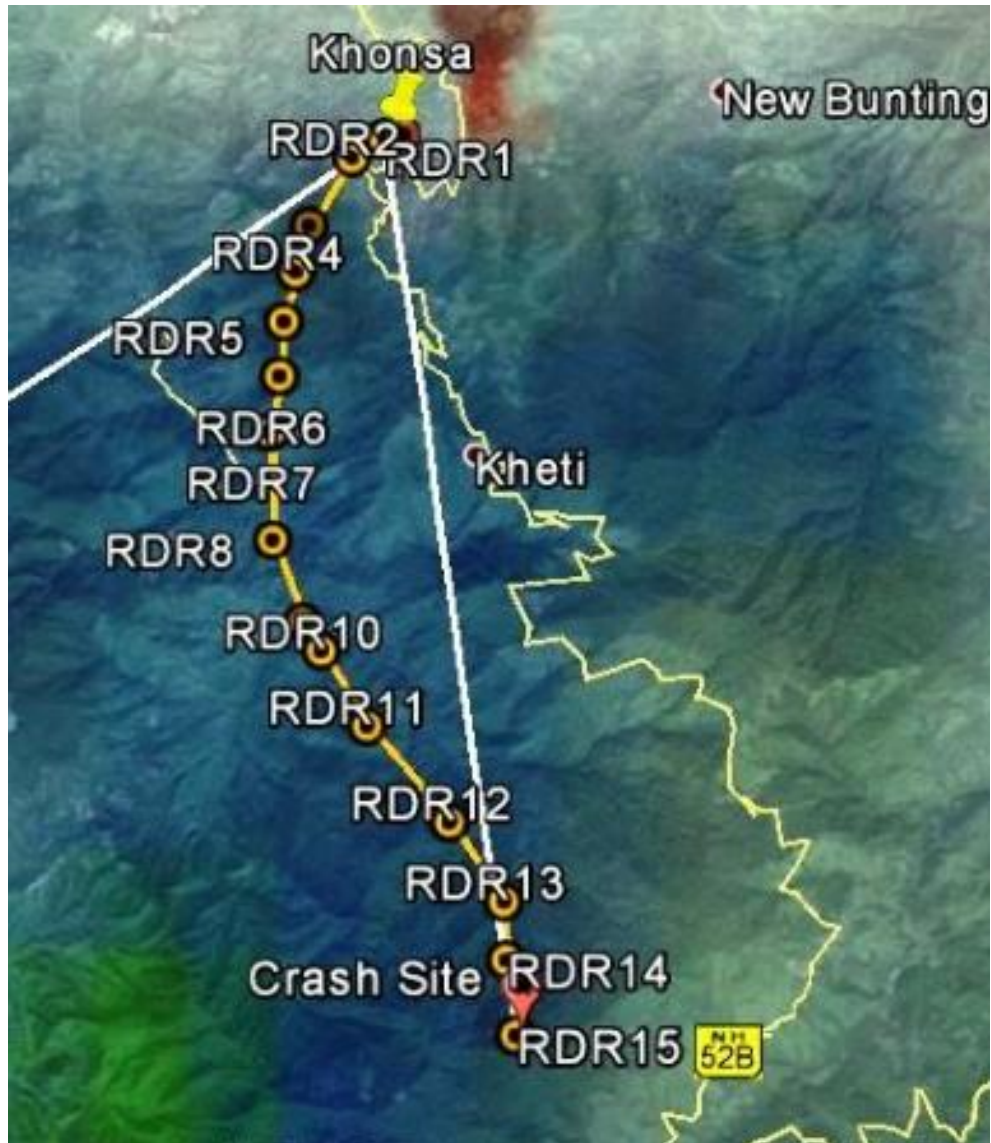
The RADAR was not having the capability of giving weather picture. Against the plot in the picture below, is also shown the weather as available at the time of accident with color coding (variation) of the clouds.
