REPORT

**ON ACCIDENT TO M/S PIONEER FLYING ACADEMY
CESSNA-152 AIRCRAFT VT-PSJ AT VILLAGE
DHANIPUR, DISTRICT ALIGARH (UP) ON 29/07/2011**

**AIR SAFETY DIRECTORATE
O/o DIRECTOR GENERAL OF CIVIL AVIATION
OPP. SAFDARJUNG AIRPORT, NEW DELHI**

**REPORT ON ACCIDENT TO M/s PIONEER FLYING
ACADEMY CESSNA-152 AIRCRAFT VT-PSJ AT
VILLAGE DHANIPUR, DISTRICT ALIGARH (UP)
ON 29/07/2011**

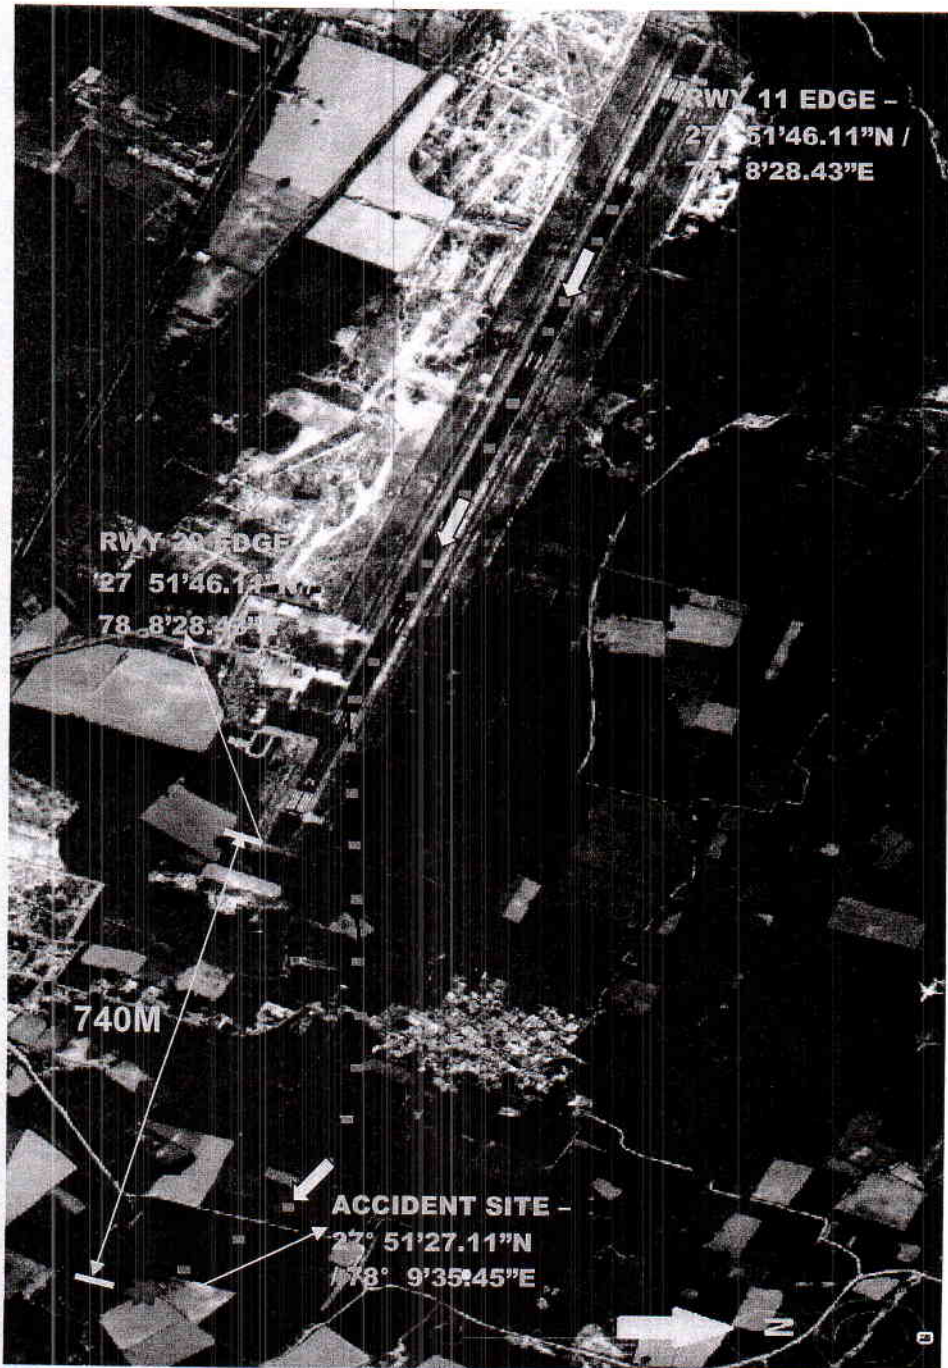
Fig. 1: Probable Flight path of the aircraft and the location of Crash site.

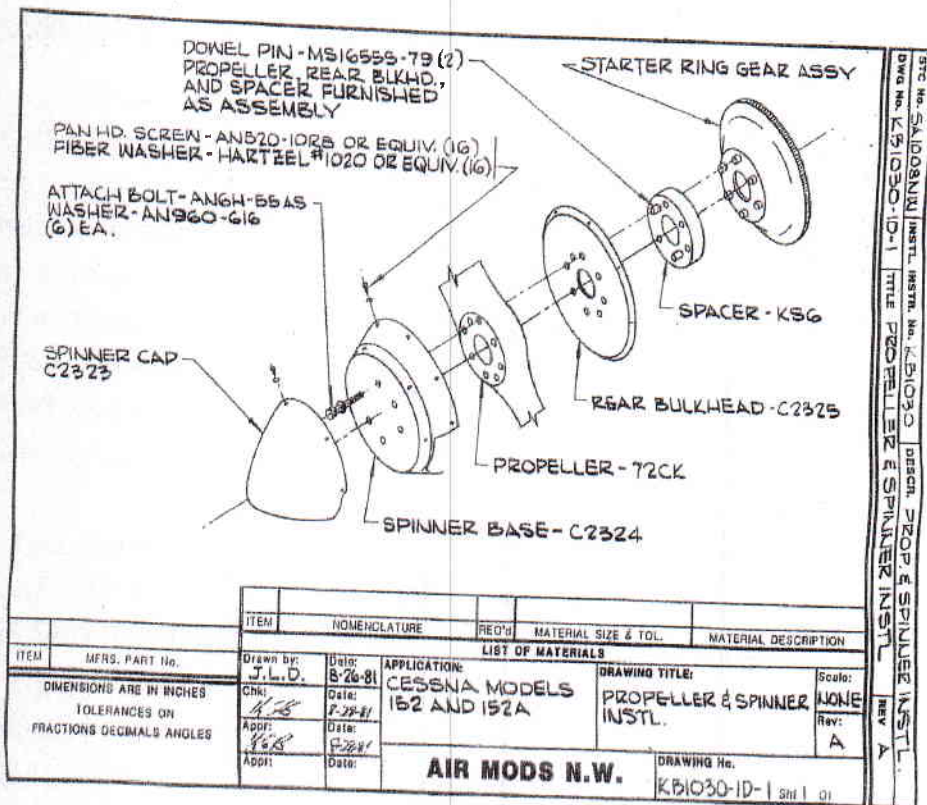
The propeller assembly consists of spinner cap, Spinner base, propeller rear bulk head, spacer and starter ring gear assembly. The rear bulkhead (or back plate) of the spinner is installed between the propeller and propeller spacer. The propeller and spacer are balanced as a unit. The propeller assembly is mounted on the crankshaft flange with six bolts. The bolts are tightened in the flange bushings. The bolts are torqued to 350 inch pounds and safety wire locked.

Fig.2 Propeller and Spinner Installation

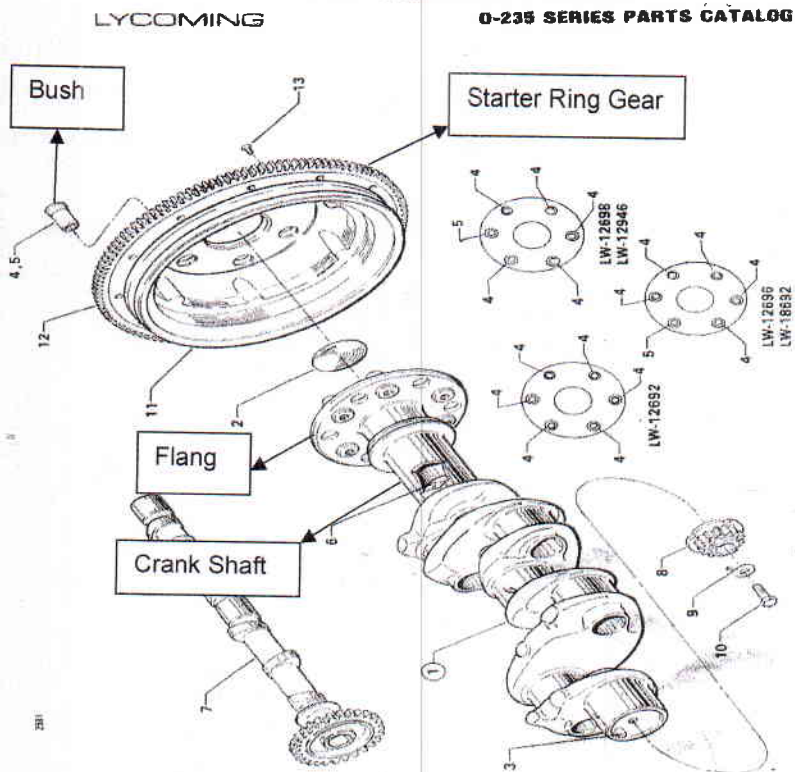
Fig. 3 Crankshaft and Related Parts

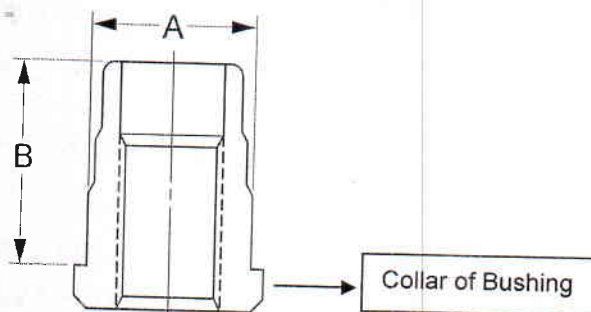
It prescribes use of bushing that will give a 0.0005 to 0.0020 in. tight fit between the bushing and its bore. The SL provides dimension 'A' and 'B' for each part no. of the bushing and also oversize for in service replacement.

Fig. 4 Bushing
