FINAL REPORT ON ACCIDENT TO M/S
SPICE JET LTD.Q-400 AIRCRAFT VT-SUA AT
HUBLI ON 08/03/2015

AIRCRAFT ACCIDENT INVESTIGATION BUREAU
MINISTRY OF CIVIL AVIATION
NEW DELHI

**FINAL REPORT ON ACCIDENT TO M/S SPICE JET LTD. BOMBARDIER
Q-400 AIRCRAFT VT-SUA AT HUBLI ON 08/03/2015**

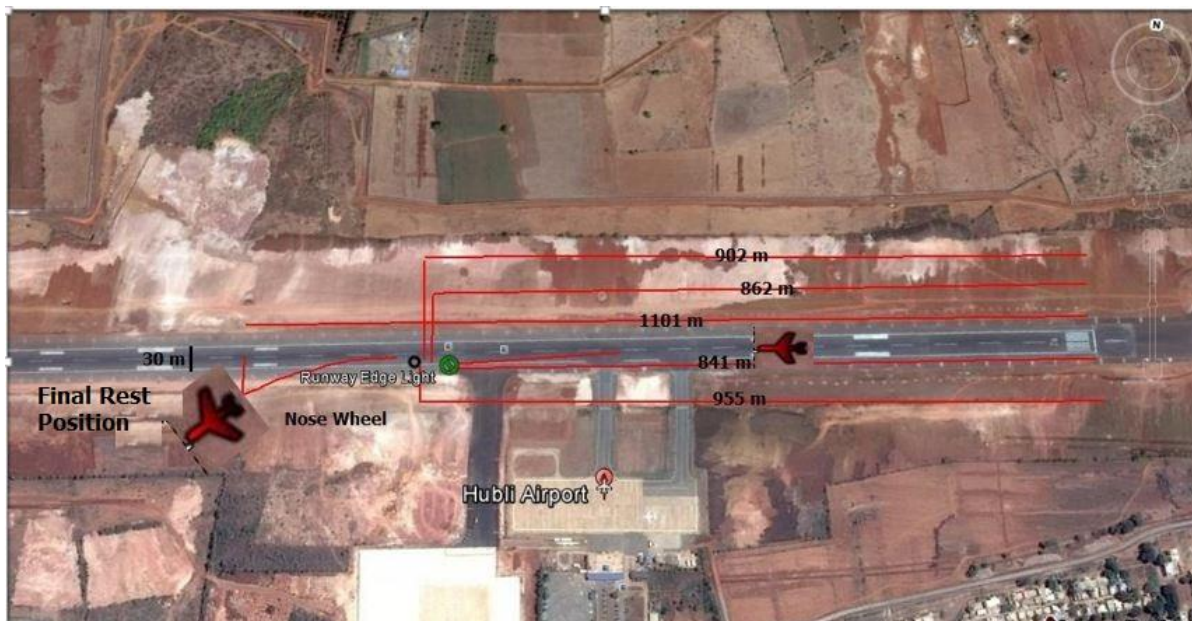
1.12 Wreckage and impact information.

During examination of the wreckage at the crash site, it was observed that aircraft had sustained substantial damage and was resting 52 m away from the left of the centre line on its belly and on the right main landing gear.

As per the evidences collected at the crash site, the aircraft landed slightly ahead of the aiming point and left to the centre line of the runway at a distance 399 m from the threshold. After travelling for about 841 meter from the threshold the aircraft overrun the runway edge light no. 56. After the impact with the runway

light, the left main landing gear collapsed. As the gear collapsed the left propeller came in contact with the runway surface at around 902 m from the threshold and all the five propeller blades sheared off from the root attachment. The area of the propeller strike marks was about 40 feet long, with approximately 2 feet between marks broken pieces of the propeller were found on the left side of the runway.

Thereafter the PIC manoeuvred the aircraft back on the runway however the nose wheel tyre failed under over load conditions and the nose landing gear collapsed and the aircraft belly came in contact with the runway surface. The nose wheel of the aircraft was found on the runway at a distance 955 m from the threshold.

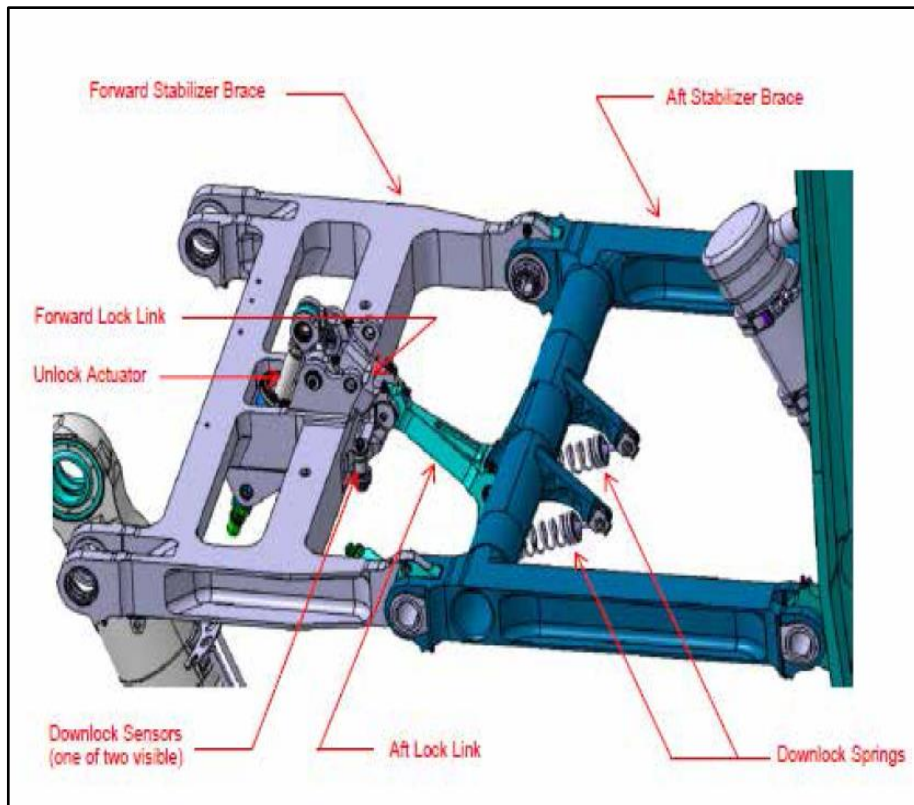
After the accident, the collapsed left landing gear assembly and the gear retraction/extension assembly was removed from the aircraft and sent to Transport Safety Board Canada in April 2015 for further investigation at the manufacturer

facility. Safety Board of Canada had sent a report in August 2016 for the accident of Jazz Aviation Q-400 aircraft and intimated that the accident to VT-SUA at Hubli was similar in nature. No separate investigation report for VT-SUA was provide by Transport Safety Board Canada to the AAIB.

The report reflected that the landing gears and all involved systems were inspected and their function checked. Both shock struts were found to be correctly serviced, and all grease points were adequately lubricated. No components had visible damage, except for the failed retraction actuator that retracts and extends the landing gear. It had failed under a compression load due to the weight of the aircraft when the gear came unlocked. The gear came unlock probably when the aircraft hit the runway edge light. The retraction actuator is not designed to hold the gear extended, but only to move it when airborne.
