FINAL ACCIDENT INVESTIGATION REPORT ON ACCIDENT TO
M/s SWAJAS AIR CHARTERS LTD., BELL 407 HELICOPTER
VT- SWA ON 19-06-2011 AT LADPUR, DEHRADUN

M/s Swajas Air Charters Ltd., Bell 407 Helicopter VT- SWA while flying from Jolly Grant Airport, Dehradun to Sehestra dhara Helipad crashed at Ladpur, Sunderwala Jungles, Dehradun on 19-06-2011 at 0854 UTC. The Helicopter was under command of Single Pilot with One (01) passenger (Aircraft Maintenance Engineer). Both pilot and passenger received injuries in the accident. There was no pre or post impact fire.

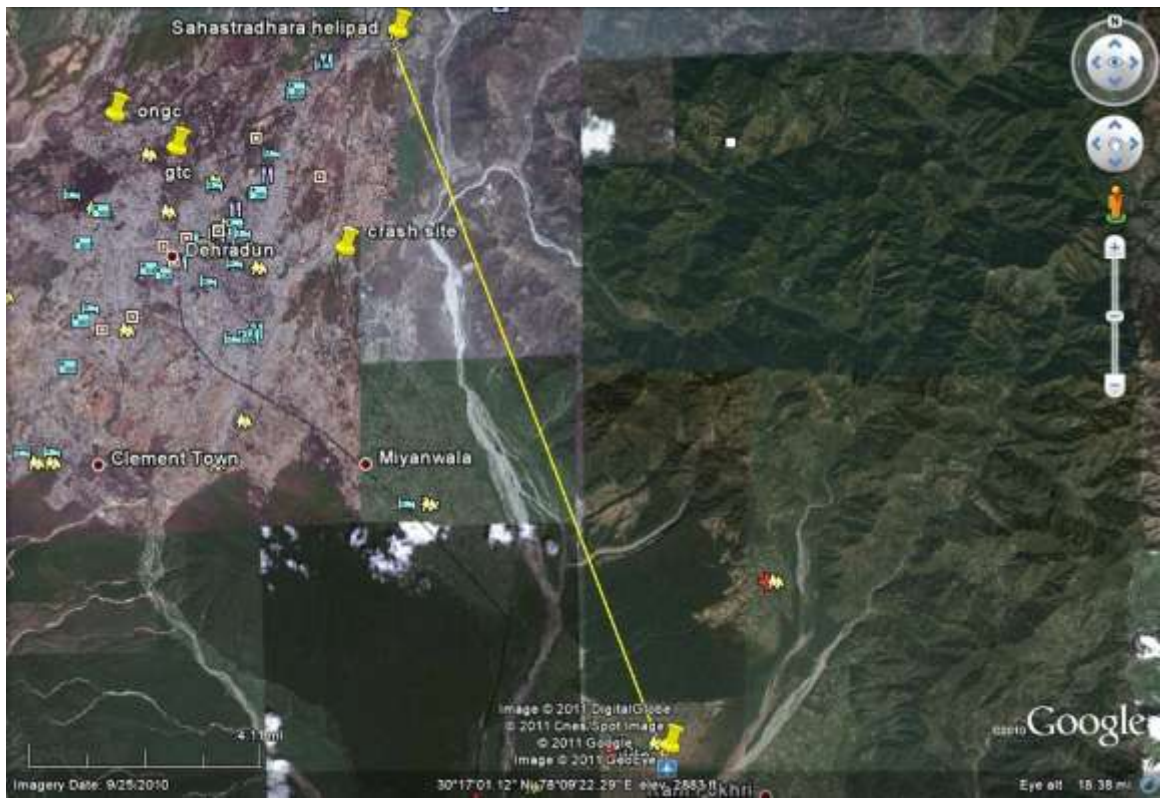
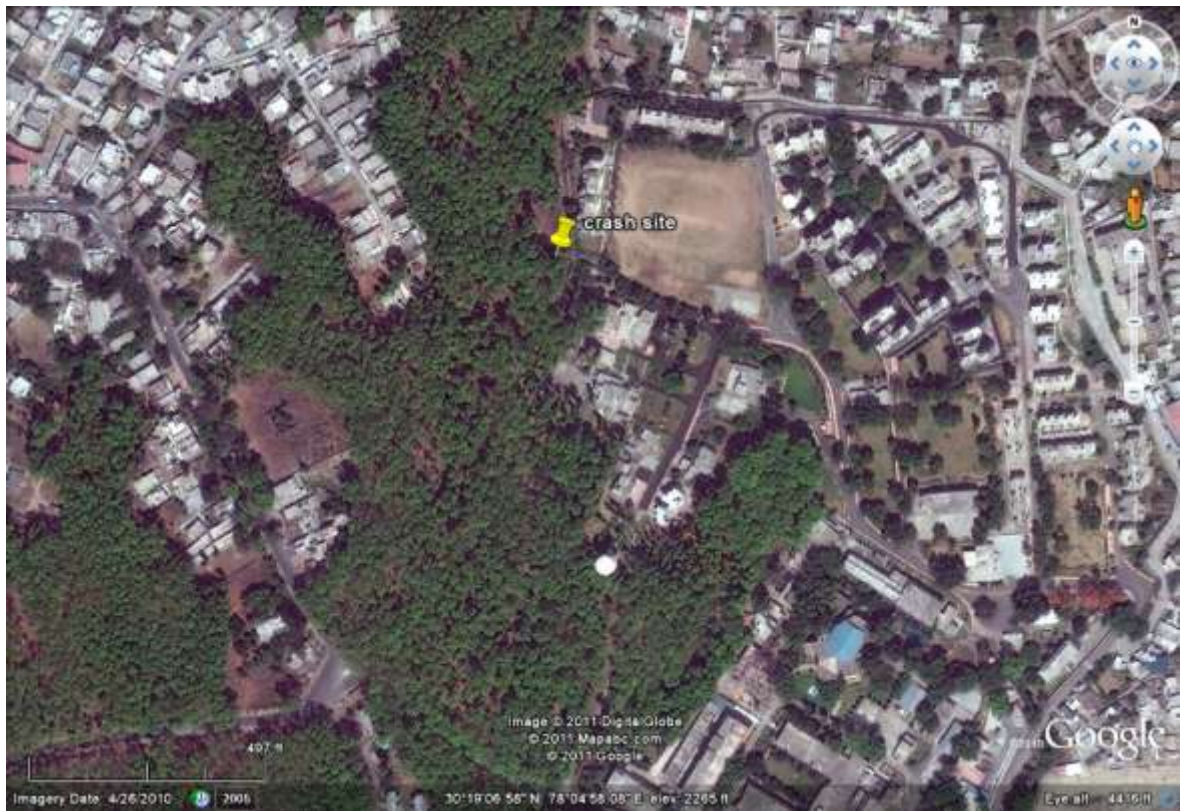
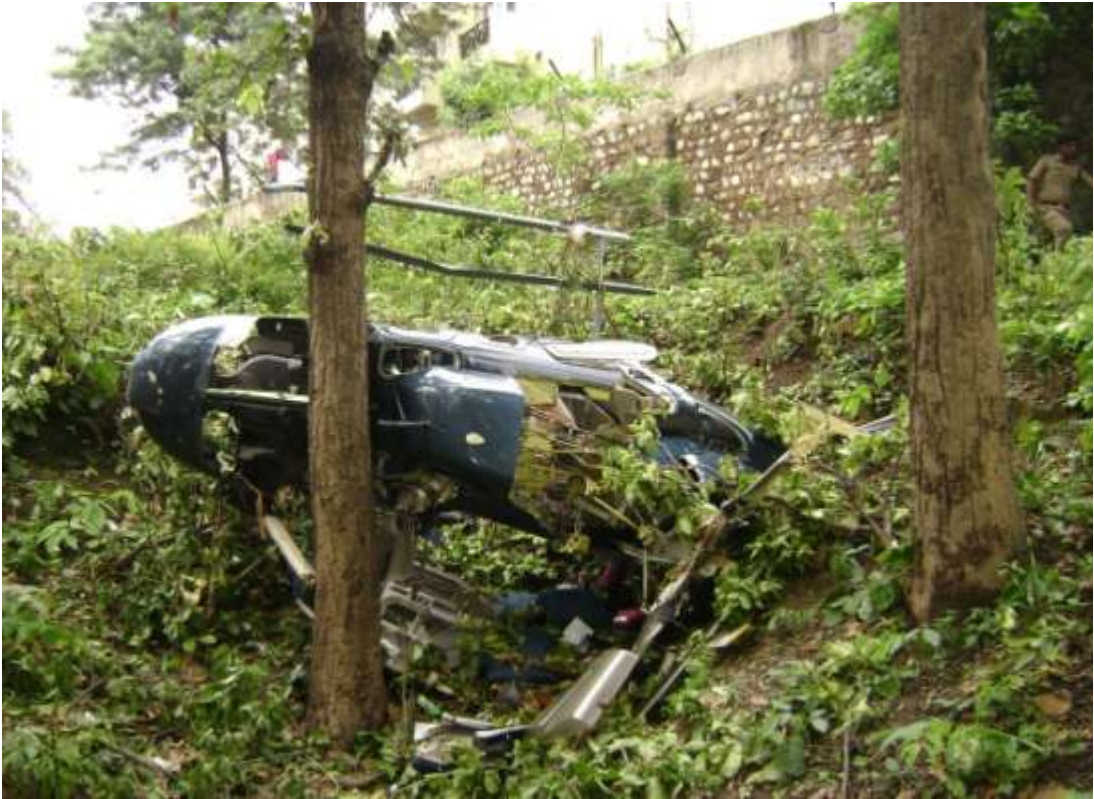
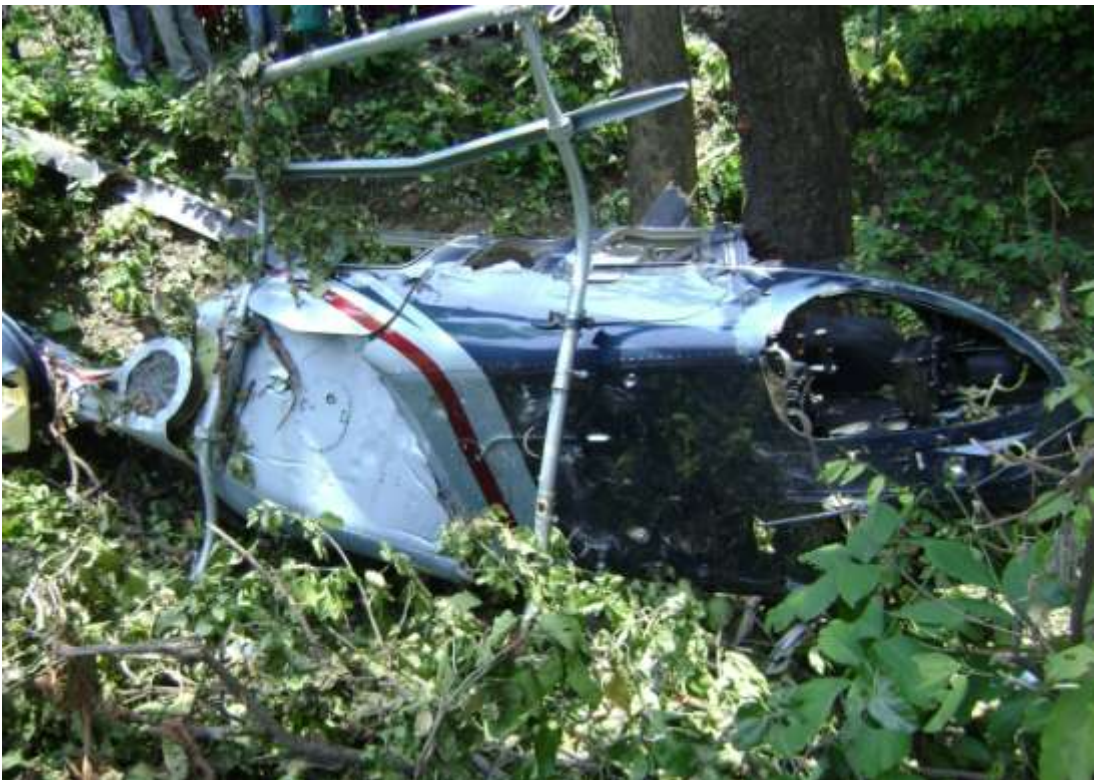
6. The helicopter impacted the ground and toppled on its left side resulting in substantial damage to helicopter.

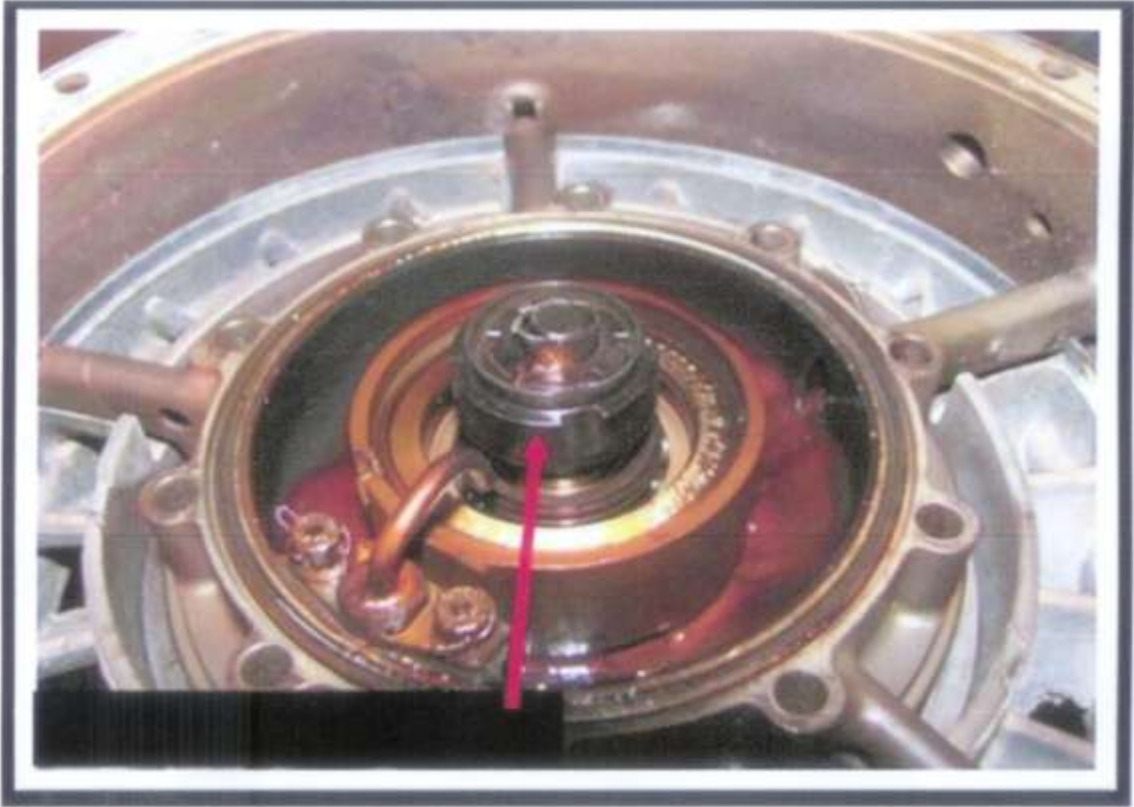
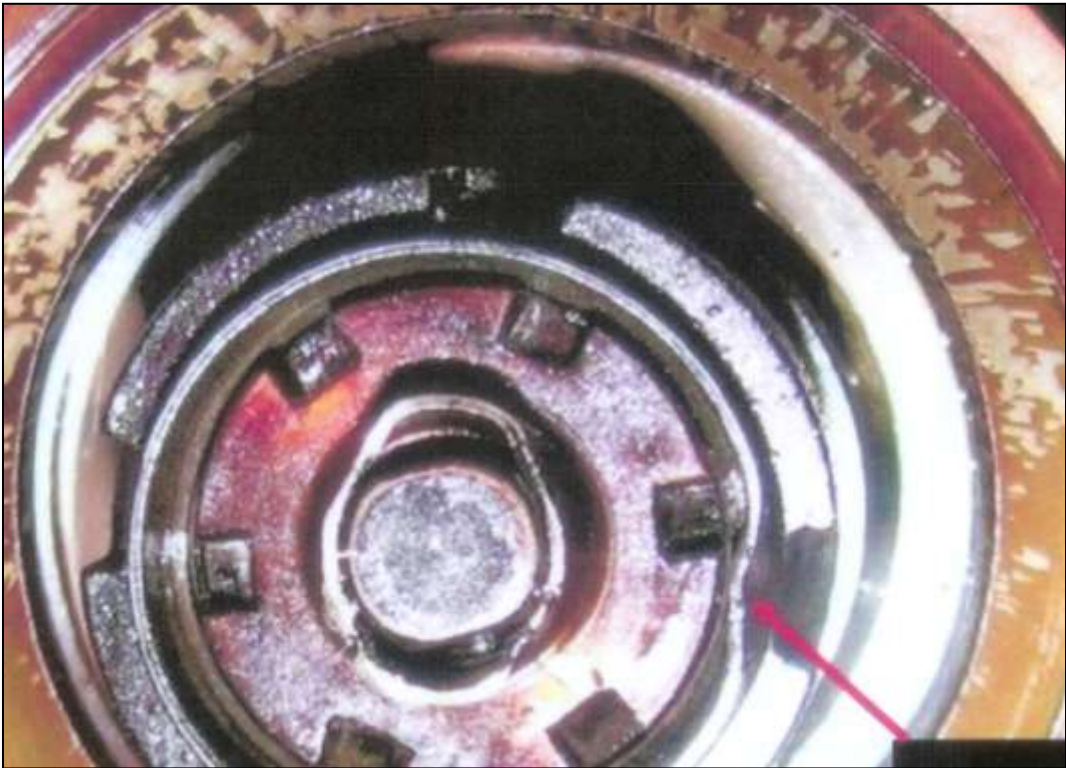
16. Engineering analysis indicates that probably # 8 bearing spanner nut back off due to improper dimple during installation. The locking dimple on nut was not properly engaged to the locking flat on the turbine stub shaft, allowing the nut to back off during engine operation. The forward displacement of the gas generator turbine

Power loss due to failure of 2nd Stage Turbine disc of engine resulted in accident.
