**FINAL INVESTIGATION REPORT ON SERIOUS INCIDENT**  
**TO M/s CATHAY PACIFIC LTD. BOEING B747-400**  
**AIRCRAFT REGISTRATION B-HUL AT IGI AIRPORT**  
**DELHI ON 27.07.2015**

**COMMITTEE OF INQUIRY B-HUL**

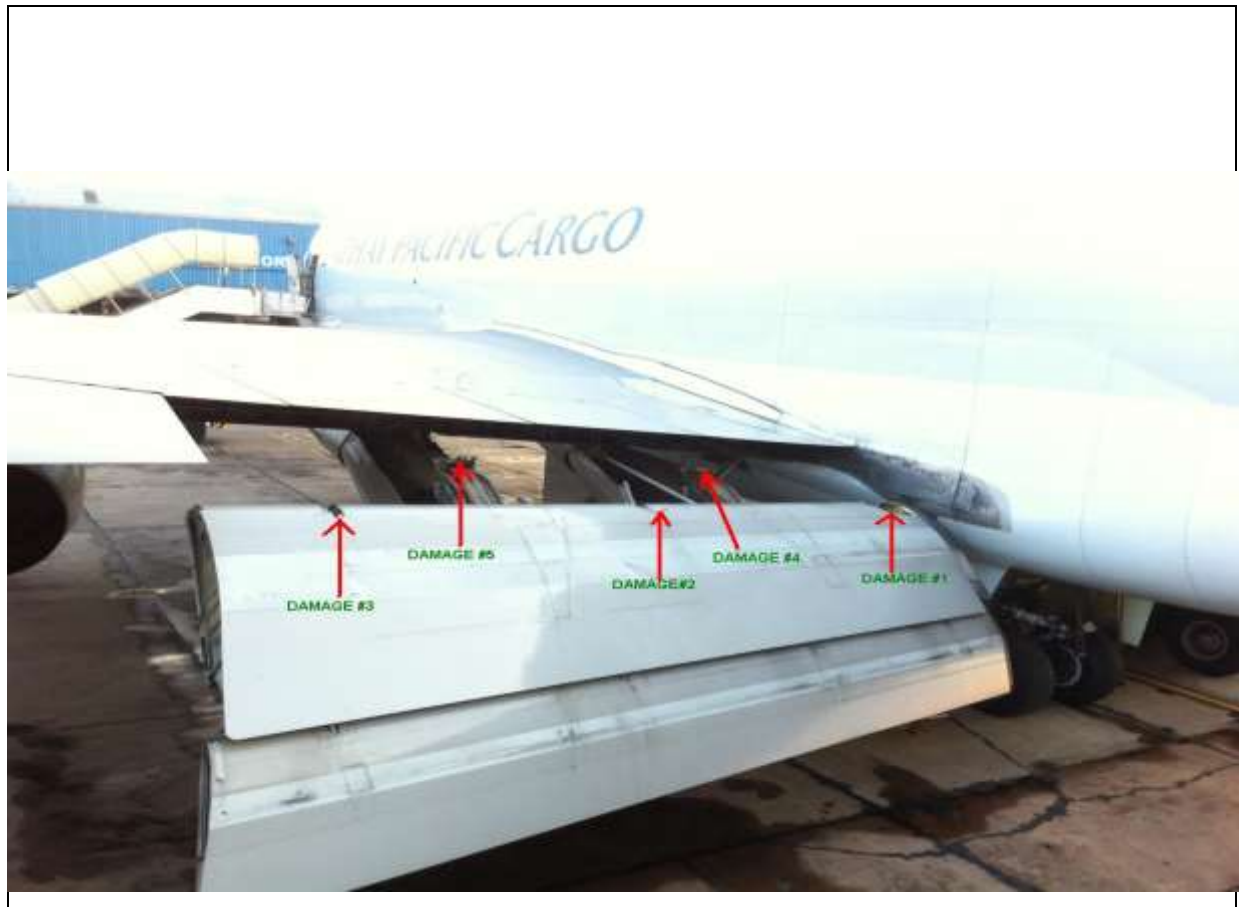
Following main damages were observed on the aircraft structure.

| Damage 1 | Damage 1A | Bull Nose of about 24 Inches from inboard edge was found missing. |
