SYNOPSIS:-

Cessna-FA152 aircraft VT-EMU operated by M/s. M.P. Flying Club was engaged in a dual flying for touch and go exercise at Devi Ahilyabai Holkar Airport, Indore on 12/06/2013. At around 1251UTC, during second sortie while climbing on the crosswind leg at approx. 2200ft, abnormal noise was heard by the crew from the engine, followed by vibrations and complete power loss. The instructor took over the controls of the aircraft and turned the aircraft towards the runway. Meantime he tried to recycle the throttle in order to regain power, but there was no response. The instructor selected an open field and carried out forced landing on cultivatable land just outside the airport. When the aircraft was about to stop, the nose wheel mired in soft soil and the aircraft toppled.

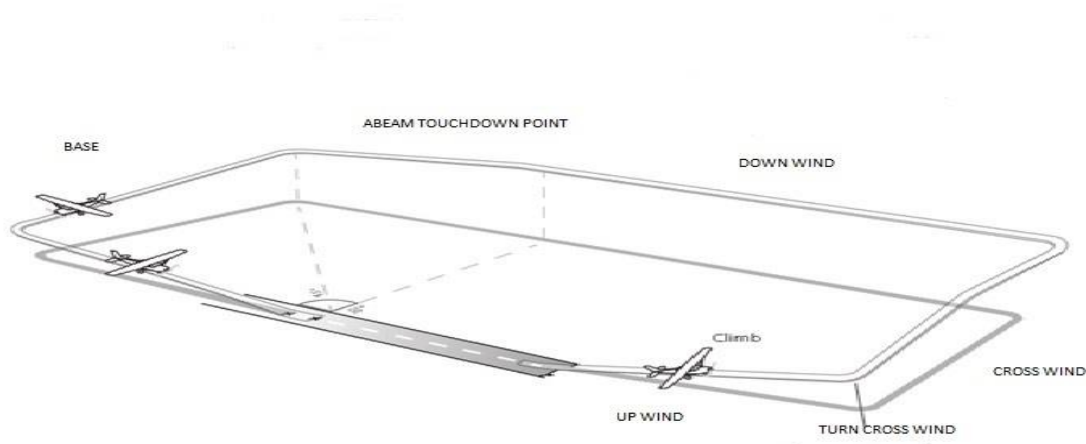
Fig: 1 Left Turn Circuit and Landing Pattern

When aircraft was in climb phase on the crosswind leg at approx. 2200ft, crew heard abnormal noise from the engine followed by vibrations and complete power loss. At this point, the instructor took over the controls of the aircraft and turned the aircraft towards the runway. He tried to recycle the throttle in order to regain power, but there was no response. The instructor selected an open field for emergency forced landing. During emergency forced landing, when the aircraft was about to stop, the nose wheel mired in soft soil and the aircraft toppled.

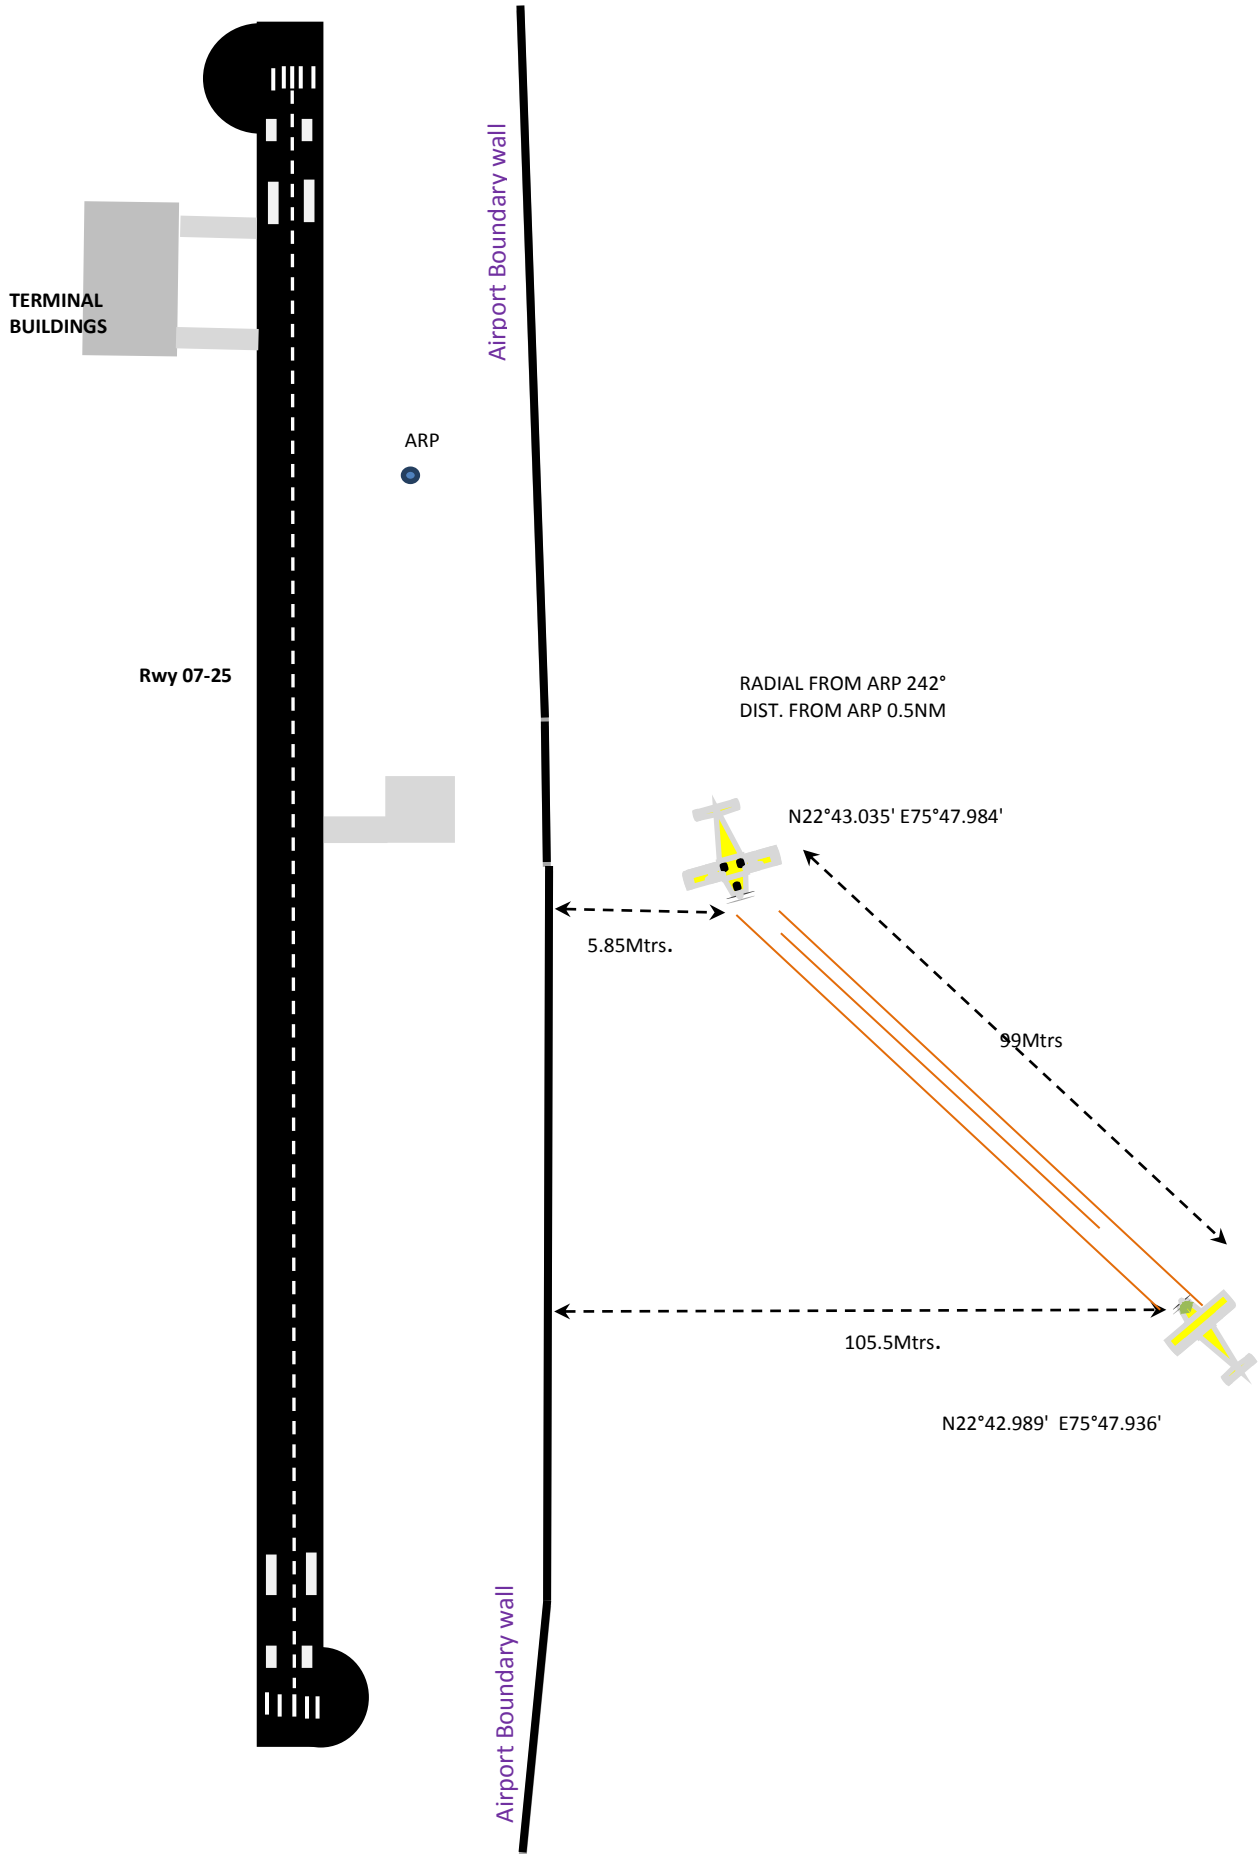
Fig: 4 Sketch of incident site with reference to the Airport (not to scale)

None of the major components of the aircraft has been detached from the fuselage. Complete wreckage was found in one place at point latitude 22°43.035'N, longitude 75°47.984'E and at elevation of 564m from sea level. The final position/direction has been shown in fig. 4. From the ground marking, it is observed that the aircraft first made contact on the cultivatable land outside the airport boundary wall at around 105mtrs from the perimeter wall of Indore airport abeam of isolation bay. After the first contact, it had rolled for approx. 99mtrs towards the wall at an angle of 60Deg. (w.r.t airport boundary wall) & came to final halt in toppled position. The distance from the perimeter wall to the final halted position was 5.8mtrs. (Approx.). It is also observed that just before the final halted position, the aircraft got toppled down because of loose soil.
