FINAL INVESTIGATION REPORT ON
SERIOUS INCIDENT TO AIR INDIA
LTD. AIRBUS A-320 AIRCRAFT VT-ESI
AT COCHIN ON 21.08.2014

FINAL INVESTIGATION REPORT ON SERIOUS INCIDENT

TO AIR INDIA LTD. AIRBUS A-320 AIRCRAFT

VT-ESI AT COCHIN ON 21.08.2014

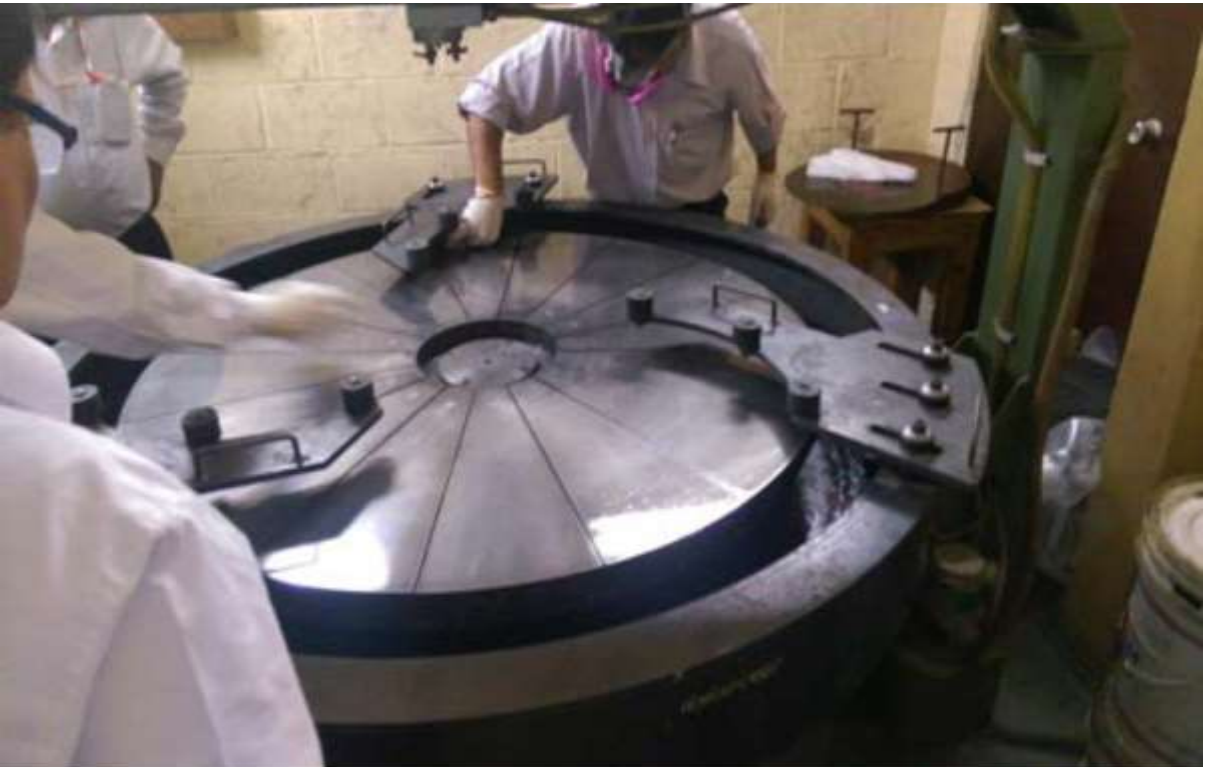
and then wiping the lapping table surface with a cloth while rotating the table. The intent of cleaning procedure is to ensure that all lapping residue from previous operations is removed. See image #2.

Image #2 - Cleaning the Table with Hicrolap solvent prior to lapping.
