FINAL INVESTIGATION REPORT

**GROUND INCIDENT INVOLING M/S ETHIOPIAN AIRLINES
AIRCRAFT ET-AMG AND M/S AIR INDIA AIRCRFT VT-EXD AT DELHI
ON 08.08.2017**

FINAL INVESTIGATION
REPORT ON GROUND INCIDENT INVOLVING M/S ETHIOPIAN AIRLINES
AIRCRAFT ET-AMG AND M/S AIR INDIA AIRCRAFT VT-EXD AT DELHI
ON 08.08.2017

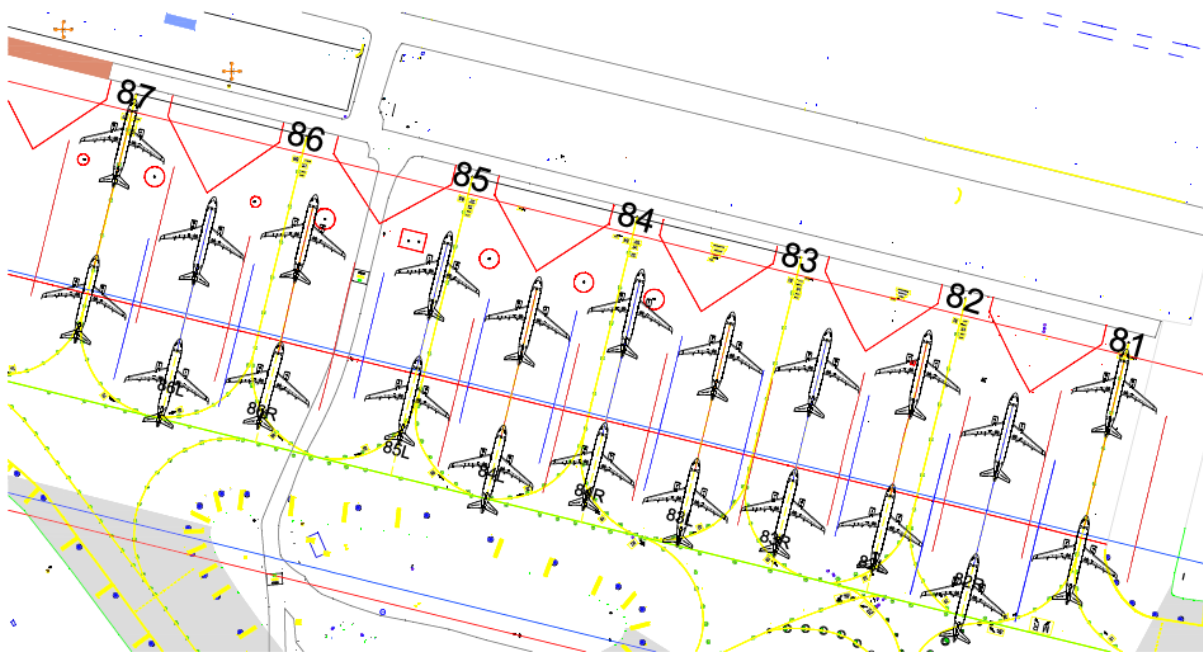
T2 Remote stand layout (not to scale).

Stand Occupied	Stand(s) Blocked
82L	82
82R	81 and 82
83L	83 and 84
83R	82 and 83
84L	84 and 85
84R	84
85L	85
86L	86 and 87
86R	86

Stand Occupied	Stand(s) Blocked
81	82R
82	82R,82L,83R
83	83L,83R
84	83L,84R,84L
85	84L,85L
86	86L,86R
87	86L
