**FINAL REPORT ON INCIDENT TO M/s INDIGO AIRLINES AIRBUS A320**  
**AIRCRAFT VT-IEU AT KATHMANDU ON 08/03/2014**

| 14. Type of incident | : Emergency evacuation due fire on right main landing gear |

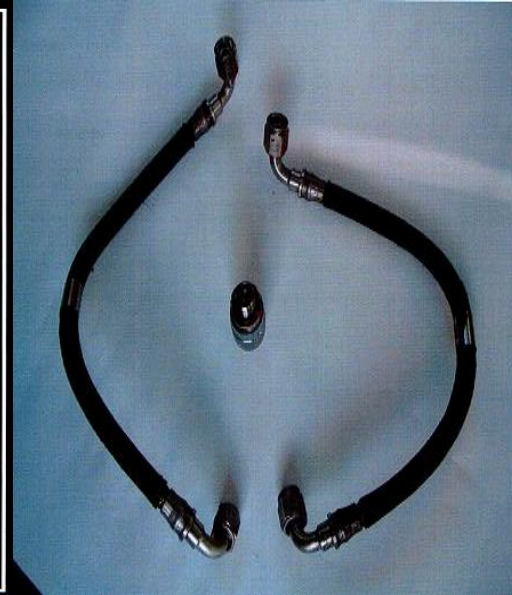
Figure 2: shows the hoses removed from the aircraft

1. Both RH main wheel # 3 & # 4 were found damaged/ deflated, however the brake assembly were found satisfactory.
2. The hydraulic hoses for #3 and #4 had fire marks.

3. The creep mark on the QAD No.4 and No.3 main landing gear wheel hydraulic system was found drift from their position.

After landing there was hydraulic leak from #3 and #4 main wheel hydraulic hoses connector plugs. The hydraulic fluid when came in contact with the hot brakes it caused dense smoke and eventually fire. The fire extinguisher bottle which was positioned near the aircraft was deployed by the ground personnel's for fire fighting and to control the fire. The fire was controlled even before the airport fire services vehicles arrived at the aircraft.

Both the hose pipes along with quick release coupling were examined under the stereo microscope up to a magnification of 50X. On both the hoses common marks were observed which were;
