**FINAL REPORT OF SERIOUS INCIDENT TO M/s JET  
AIRWAYS ATR 72-500 AIRCRAFT VT-JCV AT  
CHANDIGARH AIRFIELD ON 02/03/2012**

1. Aircraft  
    Type : ATR 72-500  
    Nationality : INDIAN  
    Registration : VT - JCV
2. Owner/ Operator : Injet Leasing Company Ltd/Jet Airways
3. Pilot – in –Command : ATPL holder on type  
    Extent of injuries : Nil
4. First Officer : CPL Holder qualified on type  
    Extent of injuries : Nil
5. Place of Incident : Chandigarh Airfield
6. Date & Time of Incident : 02<sup>nd</sup> March 2012 0900 UTC(Approx.)
7. Last point of Departure : Jaipur
8. Point of intended landing : Chandigarh
9. Type of operation : Schedule Operation
10. Crew on Board : 5  
    Extent of injuries : Nil
11. Passengers on Board : 28  
    Extent of injuries : Nil
12. Phase of operation : Landing
13. Type of incident : Aircraft bounced twice after touchdown thereafter carried go around.

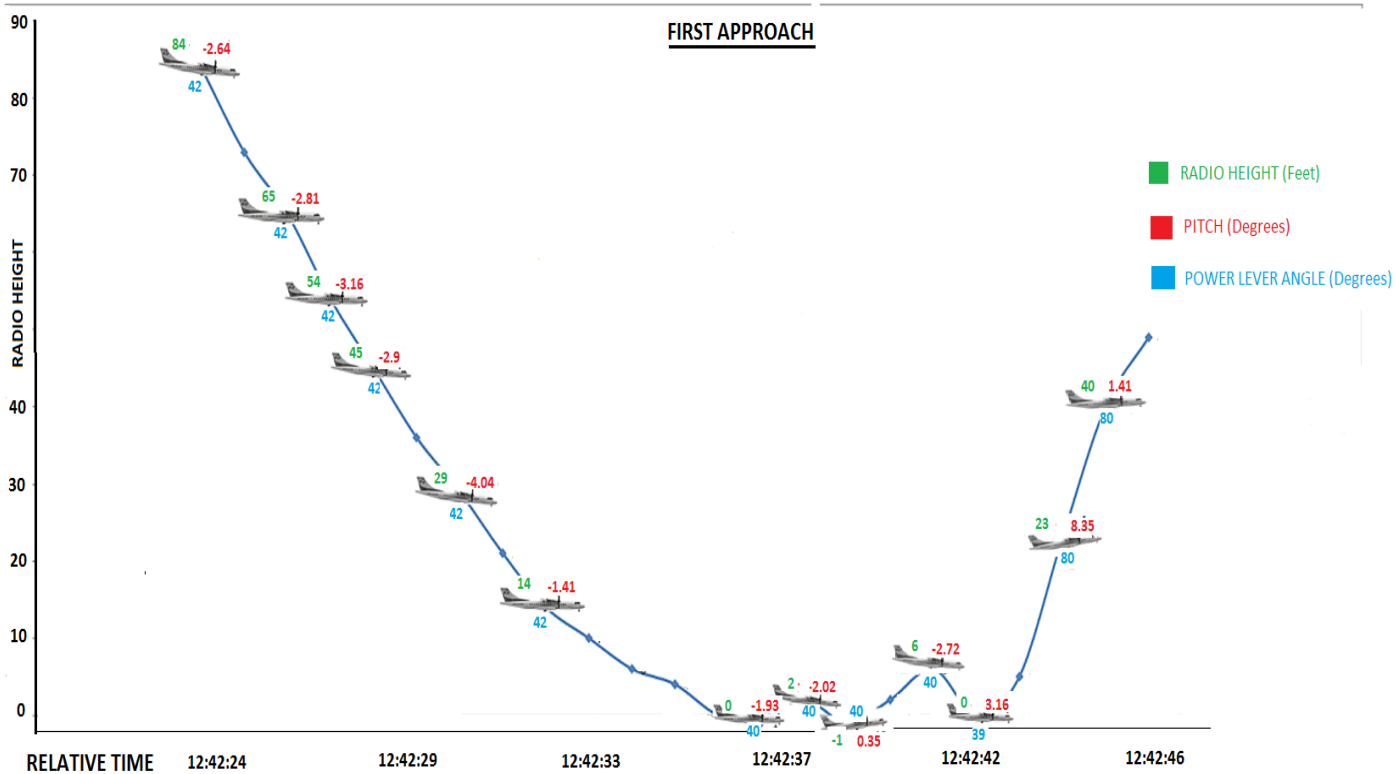
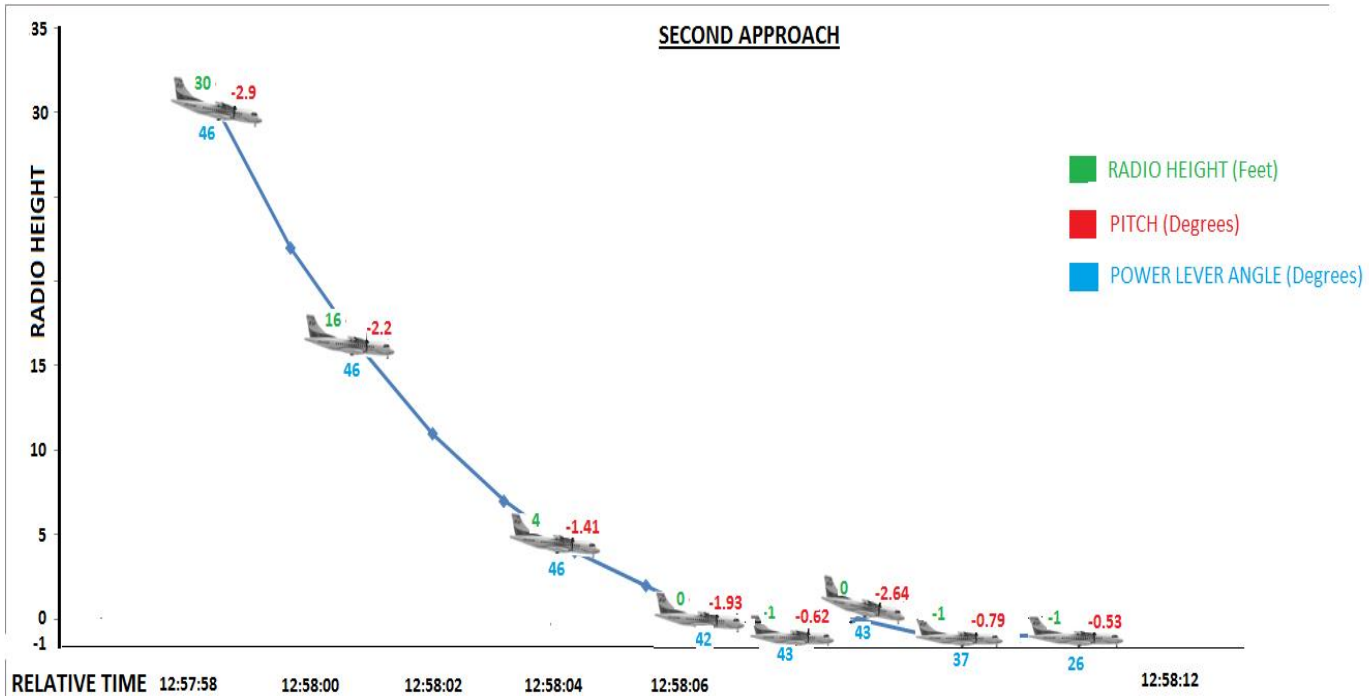
From the above it is inferred that the commander carried landing at high speed well above the Vapp speed, pitch attitude was low and pitch trim setting was nose down which resulted into couple of bounces during landing and subsequently into a go around. Hence handling of the aircraft by Commander is a contributory factor to the incident.
