**Final Investigation Report on Serious Incident to M/s Jet Airways  
aircraft VT-JEK at London Heathrow Airport on 30.08.2016**

## **Final Report on Serious Incident to M/s Jet Airways Ltd. B777-300, VT-JEK at London Heathrow Airport on 30.08.2016**

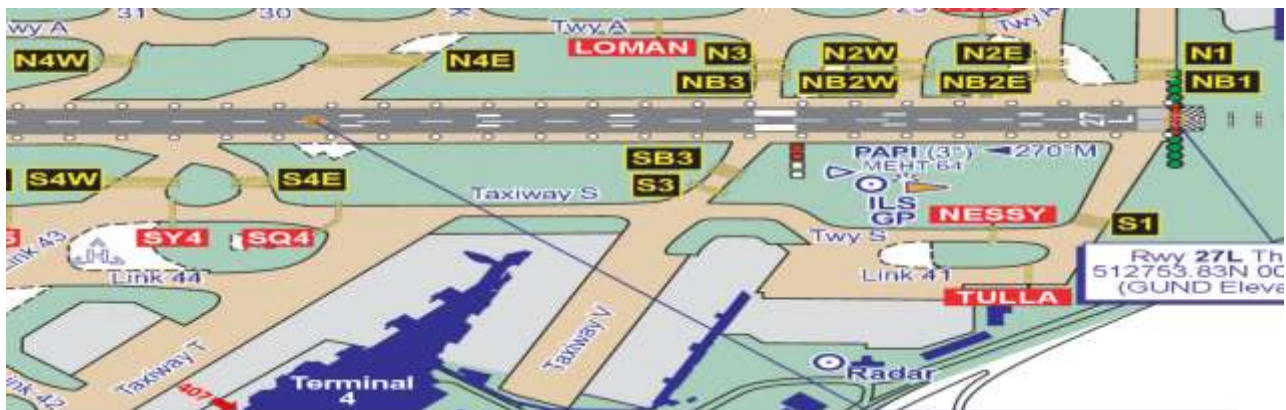
**Figure 1:** London Heathrow Airport south of Runway 27L

Jet Airways aircraft B777-300 was operating a Commercial Air Transport flight from London Heathrow Airport to Chhatrapati Shivaji Airport in Mumbai, India with 231 passengers and 15 crew on board. The aircraft departed from stand 407 and the runway in use was Runway 27L (Figure 1).

There were two NOTAMs relevant to the departure of the flight, both due to work in progress: Taxiway S east of Taxiway V was unavailable (including Link 41 and holding point S1), as was the entry to Runway 27L via holding points S3/SB3. Consequently, the flight was required to enter the runway and takeoff via entry point S4 (E or W), or to cross Runway 27L and enter the runway via one of the taxiway intersections on the north side (NB1, N2E, N2W, or N3). The Heathrow ATC tape transcript reveals that:

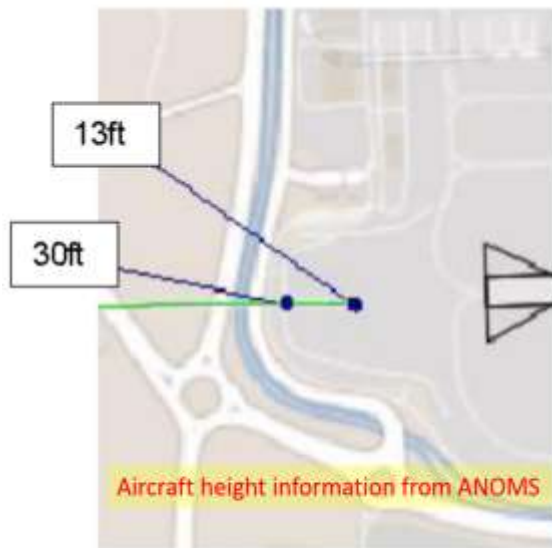
Figure 3(a) Noise Monitor

- V. When considering the reported heights of the aircraft, the following information has been obtained from both Heathrow and NATS engineers, together with a report from the Netherlands Aerospace Centre (NLR), which was commissioned earlier this year to complete a verification of the Heathrow Noise and Track Keeping System. NLR compared the raw

data received and displayed from the NATS source with separate ADS-B data in the same period.

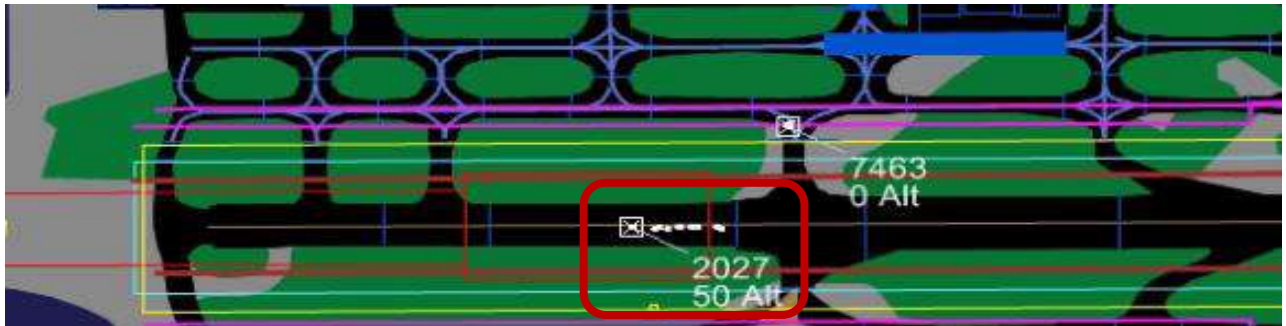
VII. ATSI reviewed the ASMGCS radar for the period 1945 – 2045 UTC, noting which of those aircraft which were based on the south side of Runway 27L, elected to take an S4 intersection departure, and those which crossed to the north side to take full length. Also, snapshots were taken of the first point an altitude was recorded by the ASMGCS for a departing aircraft, (all of whom took full-length departures.) This gave a broad picture of the point of rotation of each aircraft. Only those results which show a similar type (Boeing 777) are included in this report.

Figure 4(a): Departing **BAW 77 (B772)**

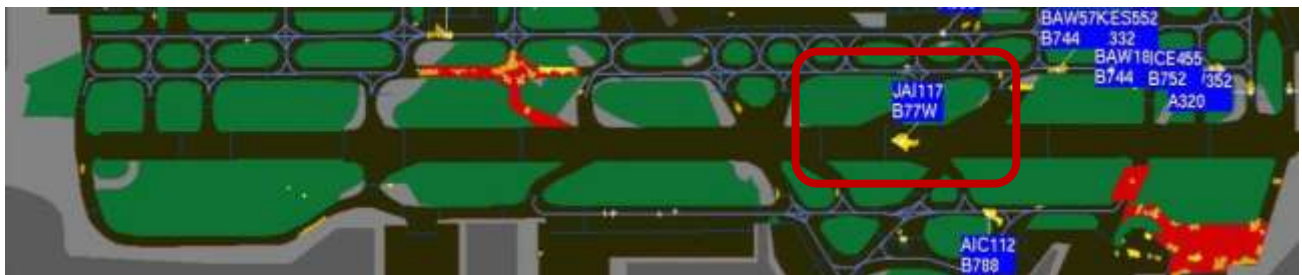
Figure 4(b): **JAI 117 (B77W) Lined up**

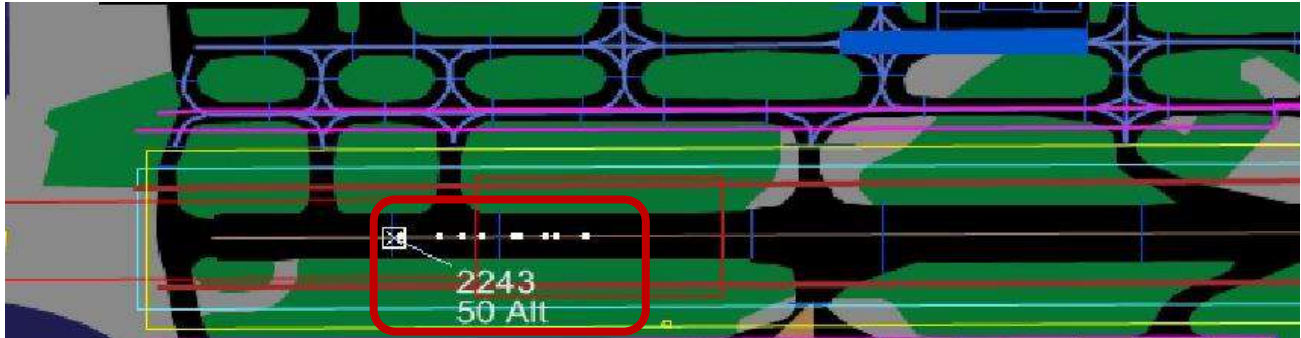
Figure 4(e): **JAI 121 (B77W) - another aircraft airborne**

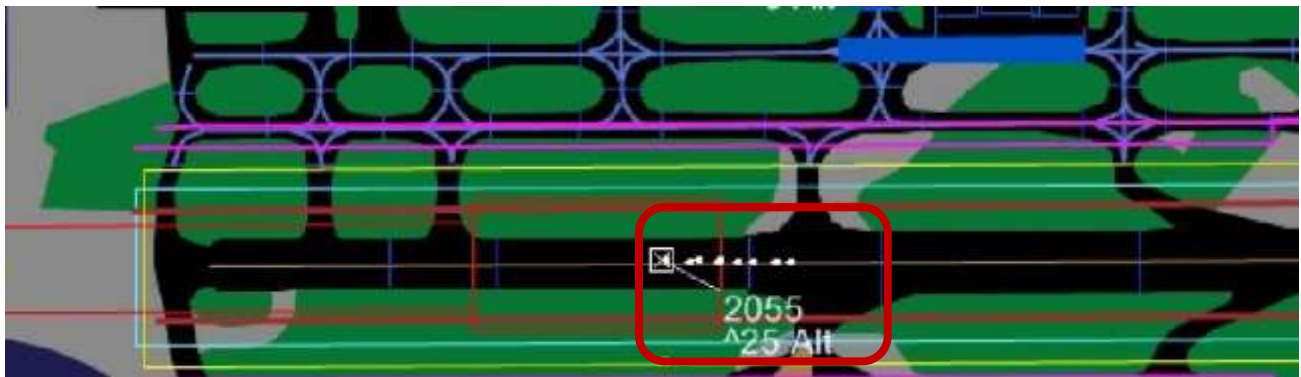
Figure 4(f): **AAR 552 (B772) airborne**

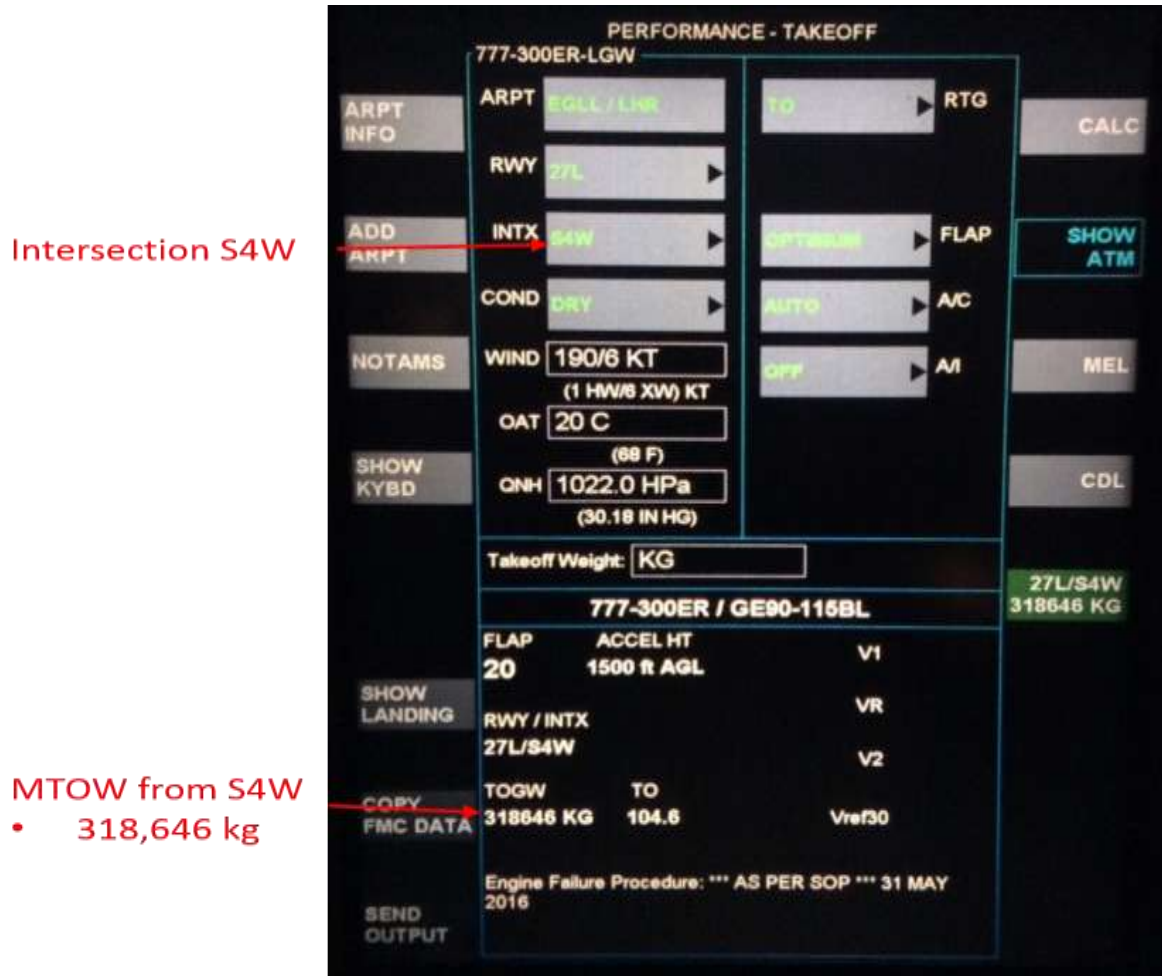
**Figure 5:** OPT calculation of MTOW from intersection S4W

As part of her pre-flight duties, the co-pilot used the aircraft's Electronic Flight Bag (EFB) On-board Performance Tool (OPT) to check whether the estimated takeoff weight was below the aircraft performance-limited maximum takeoff weight (MTOW) from intersection S4W. The calculation showed that the MTOW for a takeoff from S4W would be 318,646 Kgs using rated thrust (Figure 5). The takeoff weight was 296,885 Kgs and so a takeoff from S4W was not performance-limited.

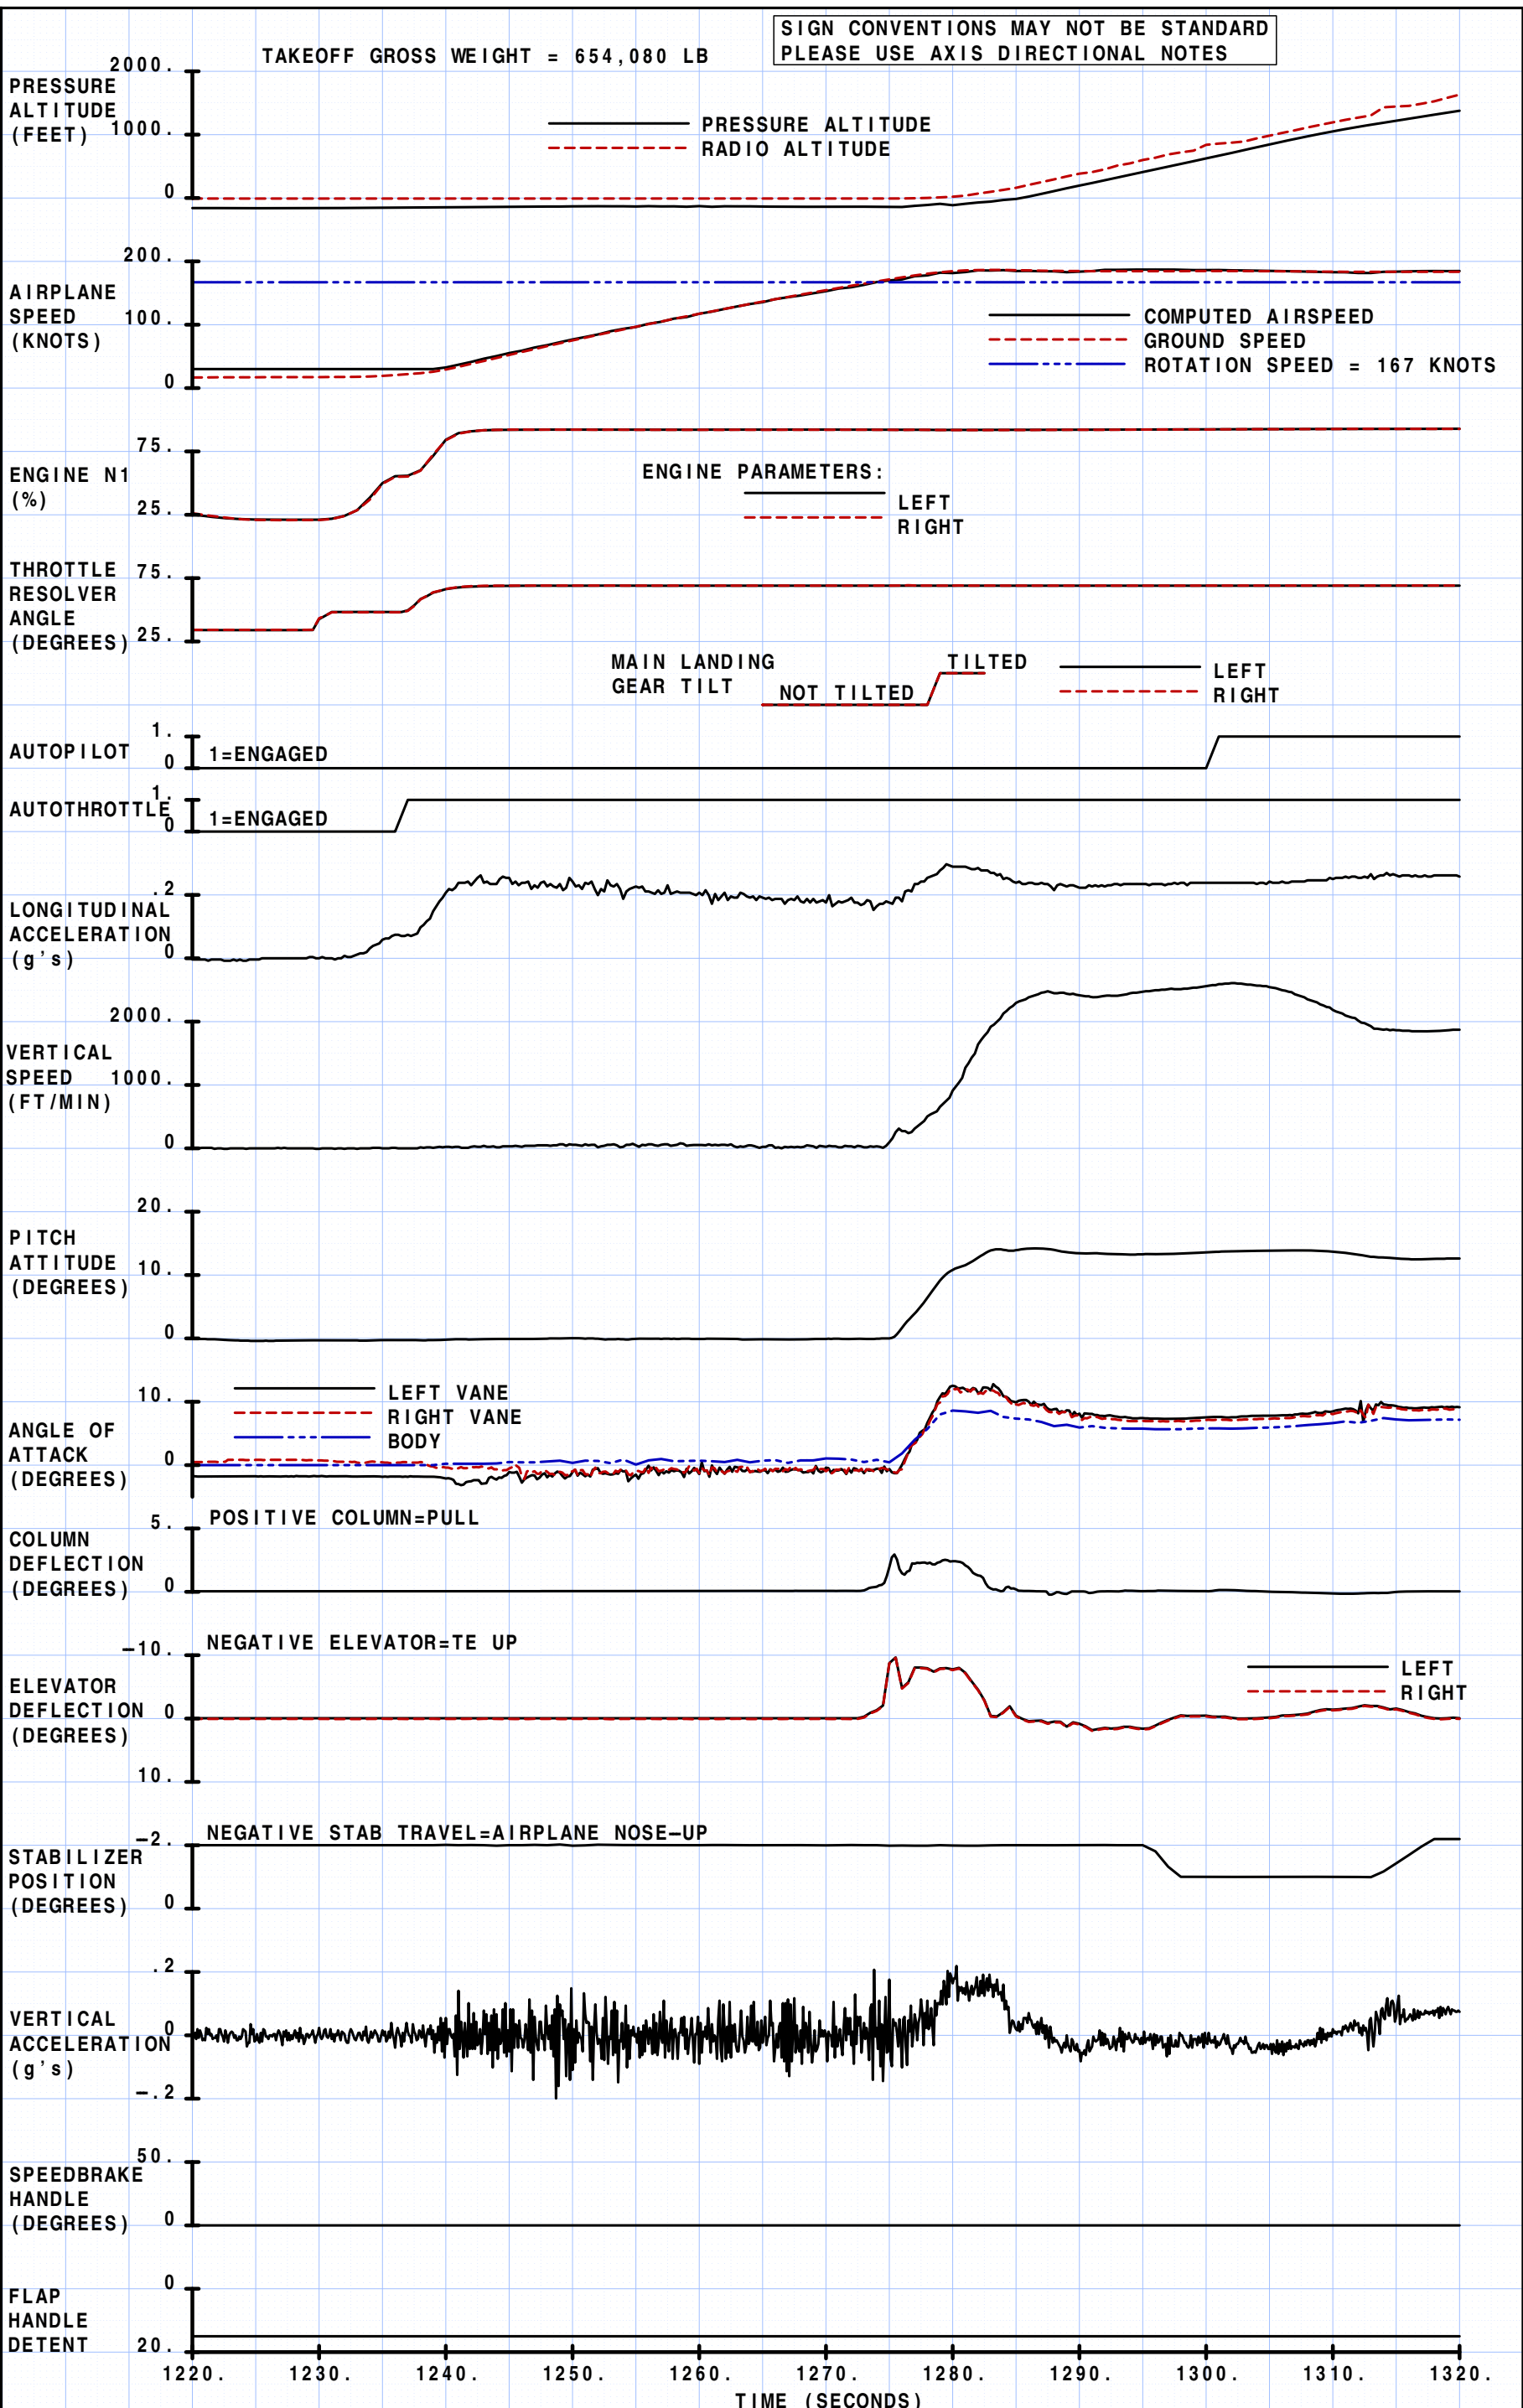
MD770/VT-JEK  
 FIGURE 1

JPL 777-300ER VERY LOW TAKEOFF  
 30 AUG 2016 . . . NON-TIME-ALIGNED QAR DATA  
 LONGITUDINAL PARAMETERS

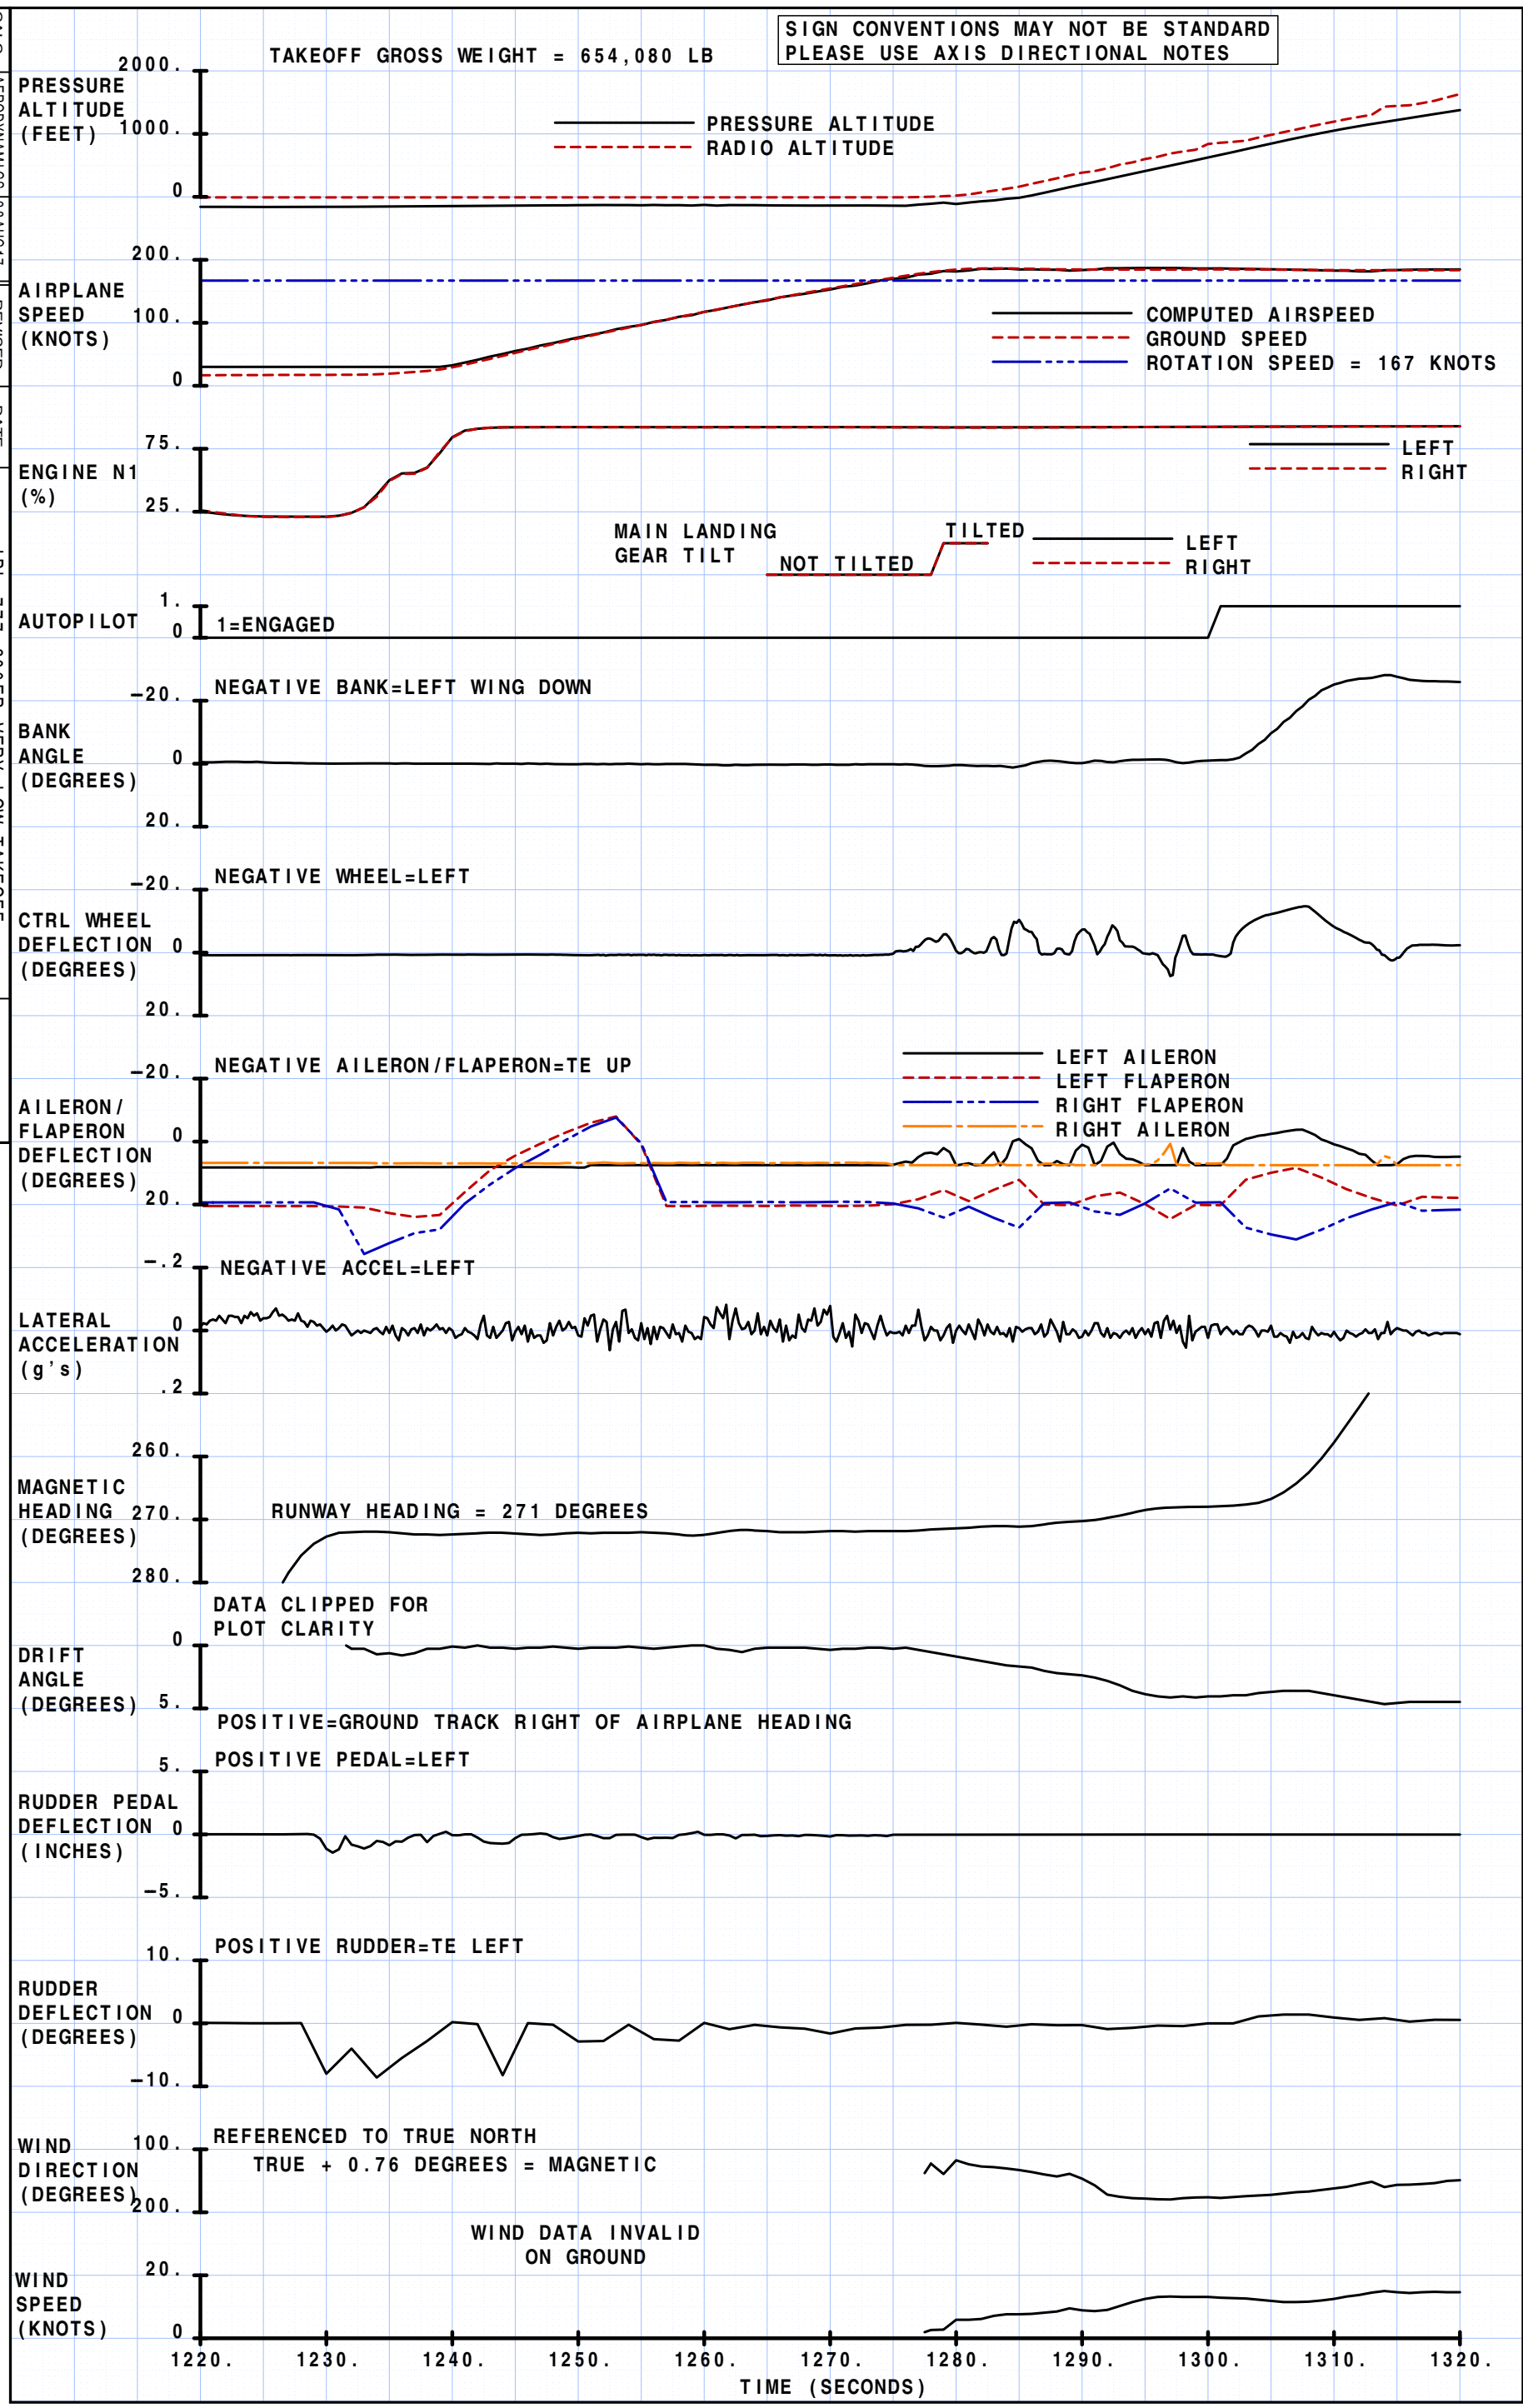
JPL 777-300ER VERY LOW TAKEOFF  
 30 AUG 2016 - NON-TIME-ALIGNED QAR DATA  
 LATERAL-DIRECTIONAL PARAMETERS

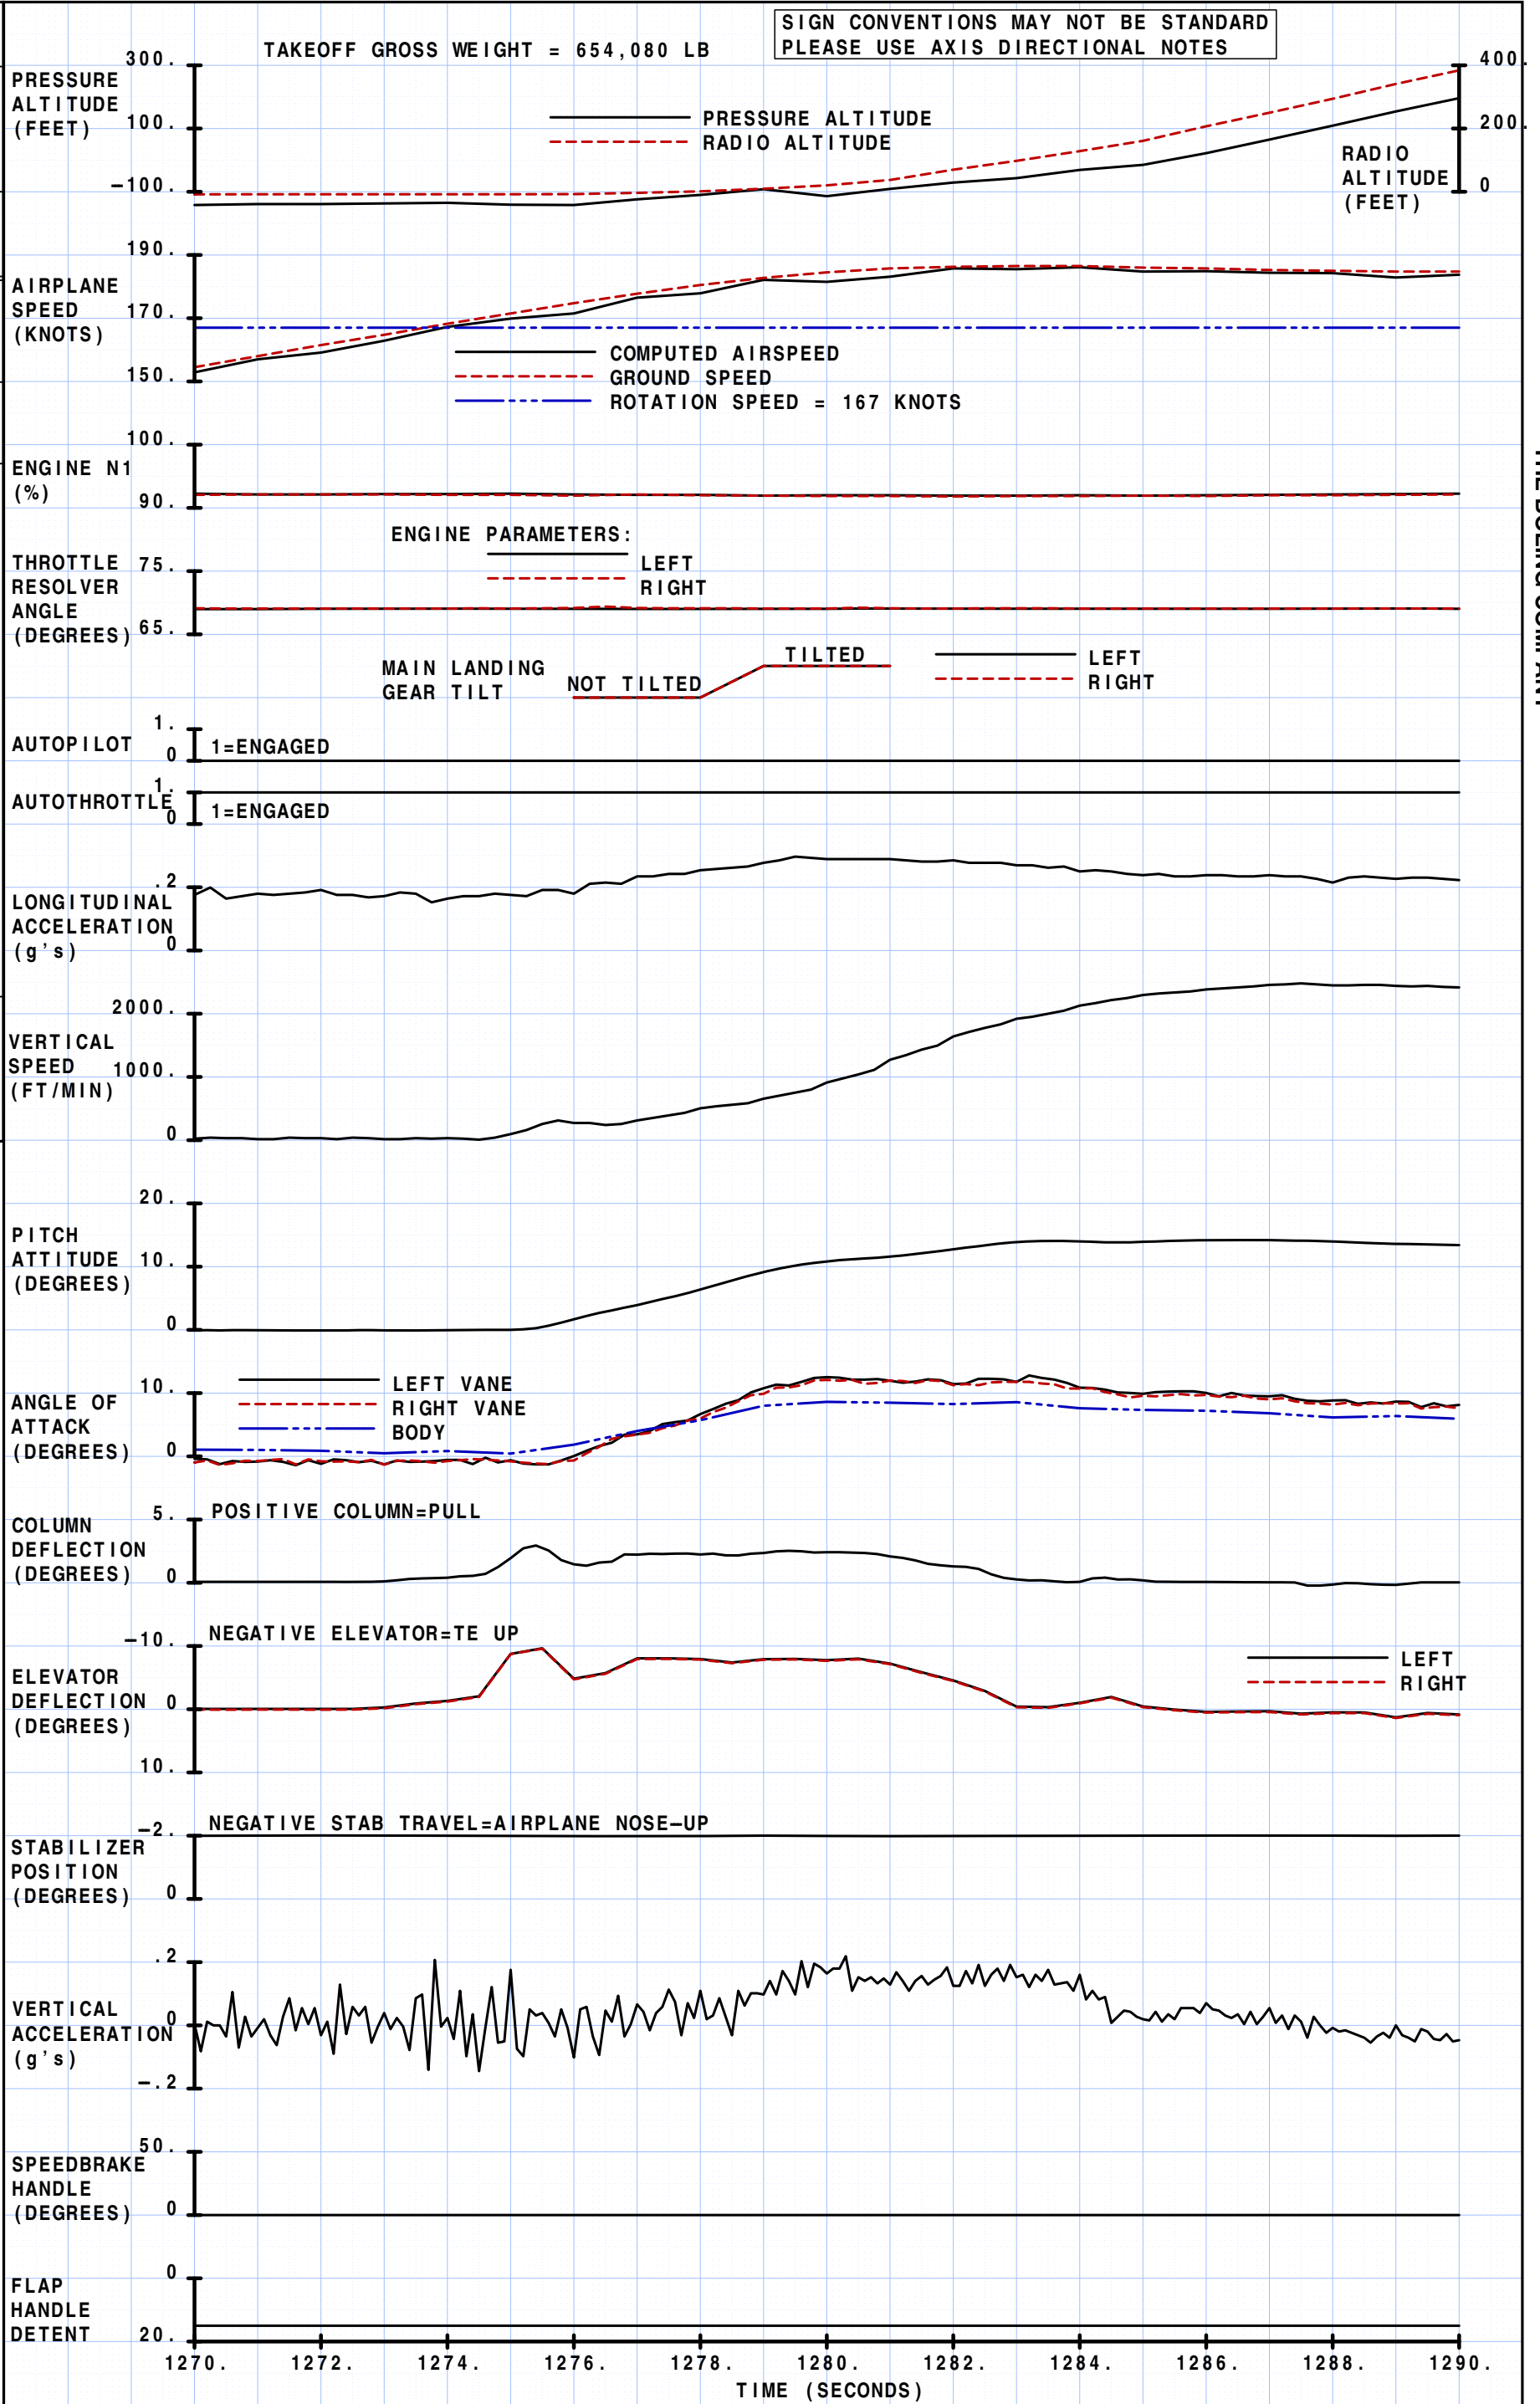
MD770/VT-JEK  
 FIGURE 3

JPL 777-300ER VERY LOW TAKEOFF  
 30 AUG 2016 - NON-TIME-ALIGNED QAR DATA  
 LONGITUDINAL PARAMETERS - ZOOM-IN

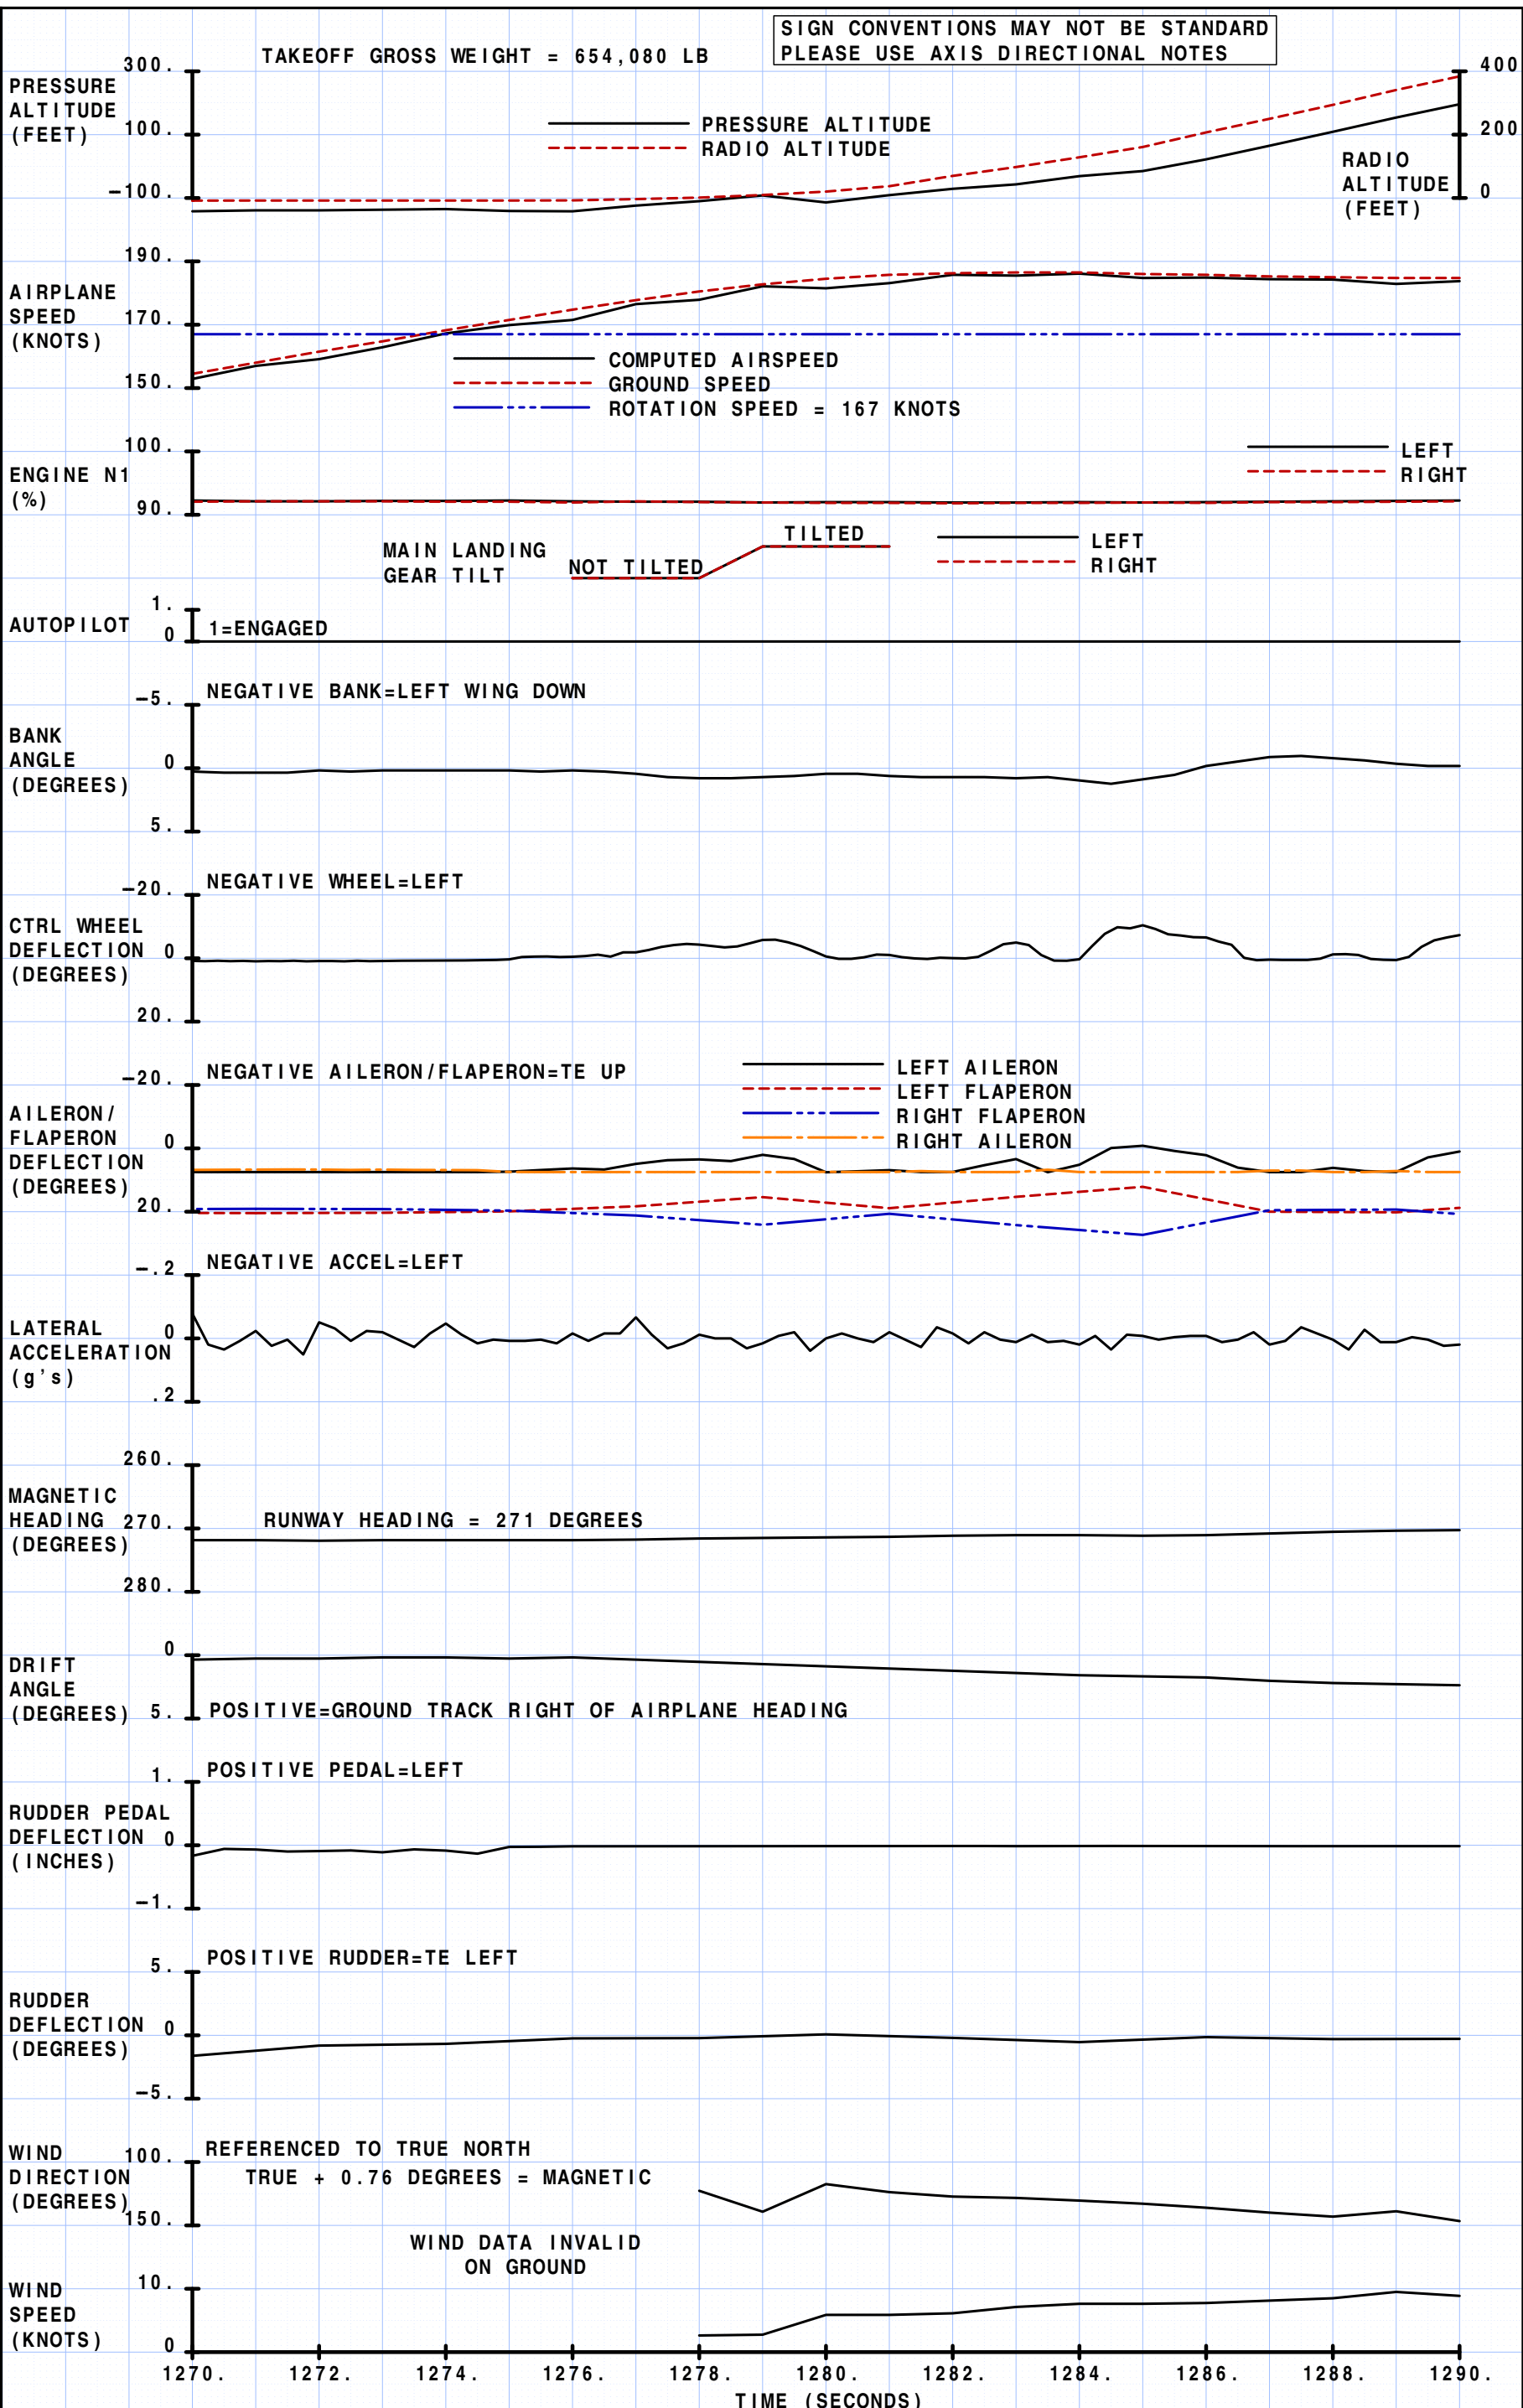
MD770/VT-JEK  
 FIGURE 4

JPL 777-300ER VERY LOW TAKEOFF  
 30AUG2016 . . . NON-TIME-ALIGNED QAR DATA  
 LATERAL-DIRECTIONAL PARAMETERS - ZOOM-IN
