Final Investigation Report on Serious Incident to M/s Mesco Aerospace Ltd. AS 350 BA Helicopter VT- MAB on 08-04-2014 at Chakwali Village, Near Saharanpur, U.P.

| 13. | Type of Incident | | Forced landing due to Tail Rotor Pitch link failure |

SYNOPSIS:

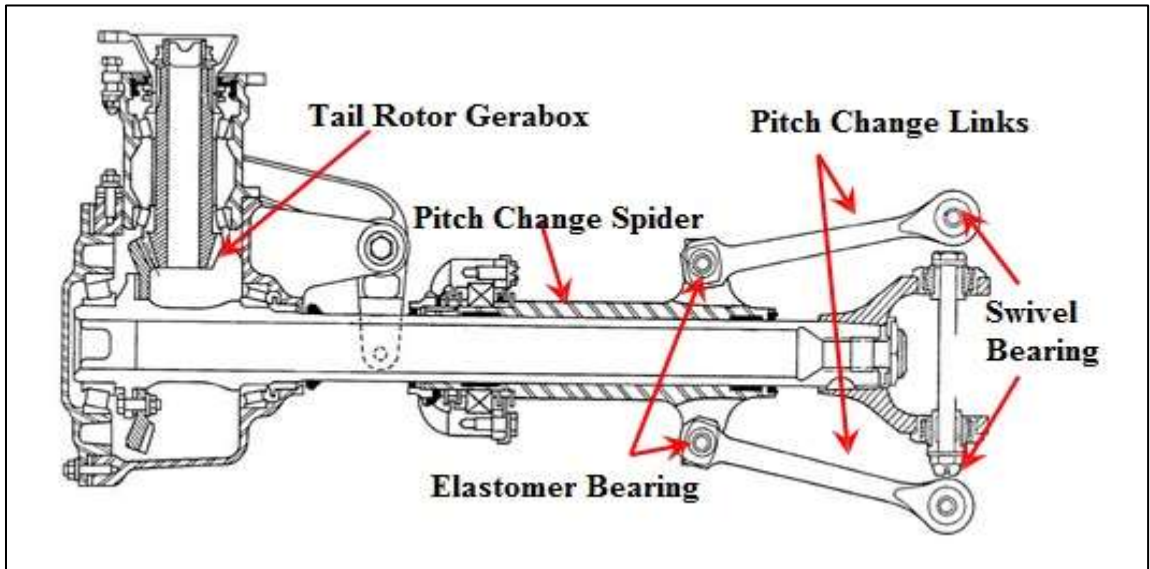
Tail Rotor Drive Assembly

The tail rotor pitch change links (02) were made of aluminum and consisted of a swivel swaged-in, self-lubricating spherical bearing at one end and an elastomer-damped sleeve-type bearing at the opposite end. The bearing is made of steel or tungsten carbide in steel race. The inner surface of bearing is lined with fiberglass impregnated with Teflon to reduce friction. The normal functional stresses including control input and centrifugal forces applied to pitch link bearing lead to wear of inner race Teflon. If preventive maintenance inspection not followed, the bearing exceed the current wear limit and allow metal-to-metal contact leading to load on tail rotor pitch change link and onset of fatigue crack in material which propagate until link fails.

The pitch change link swivel bearing was found excessively damaged. Tail rotor pitch change link of the same blade was broken from the swivel bearing side and found attached. The broken portion Tail rotor pitch change link could not be located. Metal particles were found on the TGB chip detector.

DGCA has issued a mandatory Modification DGCA /AS-350 Series /119 applicable to AS 350 and AS 355 Series Helicopters regarding “Time Limits/Maintenance Checks- Tail Rotor (T/R) Pitch Change links Inspection as per EASA AD No. 2010-0006.
