**FINAL REPORT OF SERIOUS INCIDENT TO AIRLINE  
ALLIED SERVICES LTD CRJ-700 AIRCRAFT VT-RJE AT  
CHAKERI AIRFIELD, KANPUR ON 20/07/2011**

1. Aircraft  
    Type : CRJ-700  
    Nationality : INDIAN  
    Registration : VT - RJE
2. Owner/ Operator : Alliance Air Ltd.
3. Pilot – in –Command : ATPL holder on type  
    Extent of injuries : Nil
4. First Officer : CPL Holder qualified on type  
    Extent of injuries : Nil
5. Place of Incident : Chakeri Airfield, Kanpur
6. Date & Time of Incident : 20<sup>th</sup> July 2011 0652UTC(Approx.)
7. Last point of Departure : Delhi
8. Point of intended landing : Kanpur
9. Type of operation : Schedule Operation
10. Crew on Board : 4  
    Extent of injuries : Nil
11. Passengers on Board : 55  
    Extent of injuries : Nil
12. Phase of operation : Landing
13. Type of incident : Runway Excursion

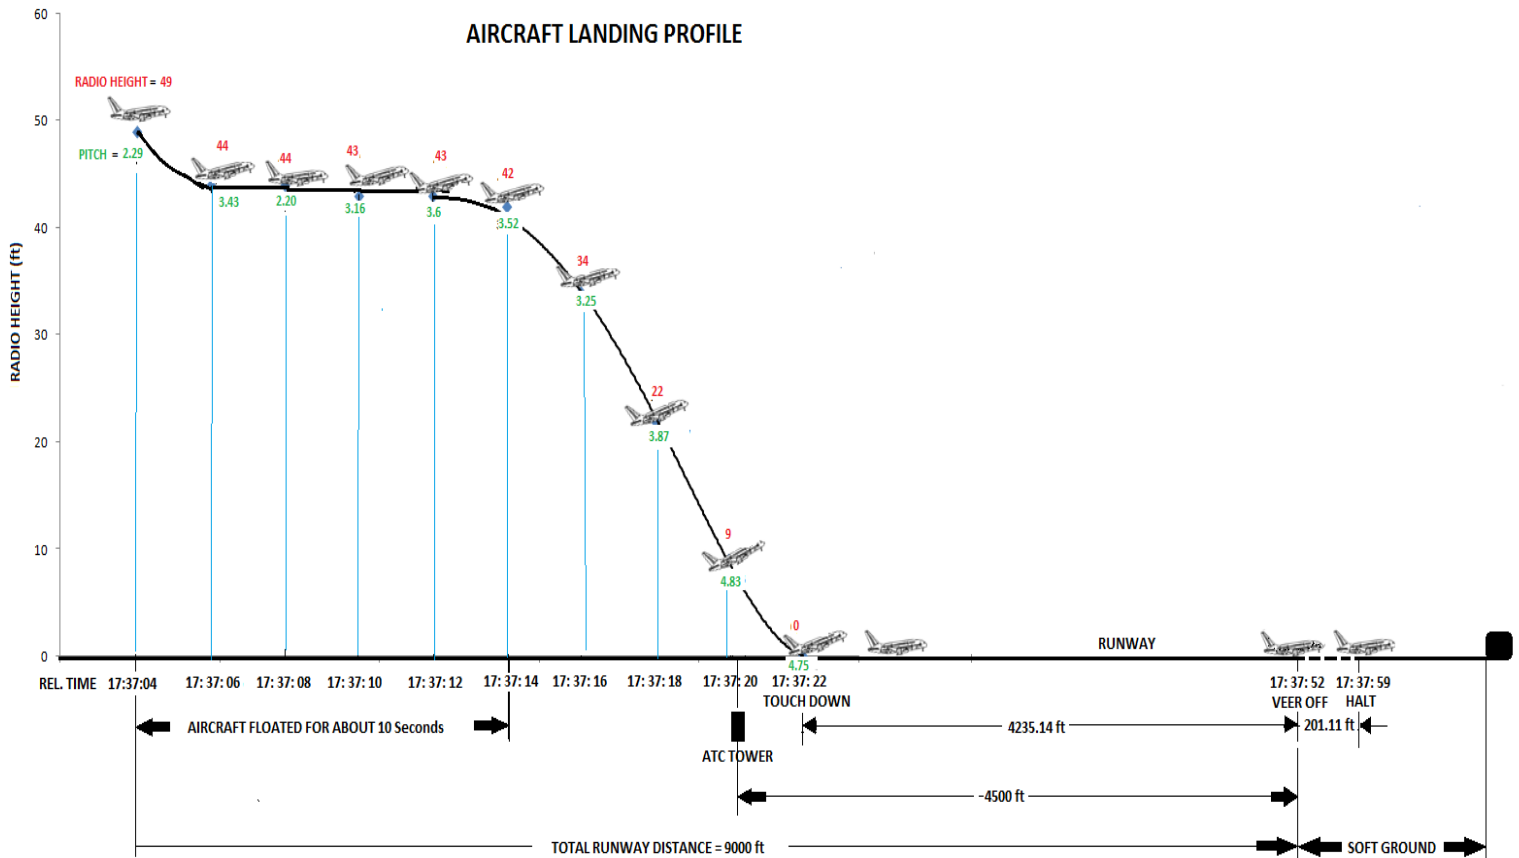
As per the DFDR analysis it was observed that at around 43 feet with a Vref of 128 knots the throttles were retarded and the aircraft was flared for landing. At that point the aircraft speed was around 135 knots and the ground speed was 146 knots which implies that at the time of landing the tail wind component was around 11 knots. The winds reported by the tower at the time of landing was 05 knots variable. As per the Flight Crew Operating Manual of CRJ 700 the maximum tail wind component for this aircraft for landing is restricted to 10 knots. Once the power levers were retarded the aircraft floated for about 10 seconds before the Commander landed the aircraft. Thereafter the aircraft rolled on the paved surface for about 28 seconds and then veered off to the right of center line and exited the runway at around 44 knots and then rolled for another seven seconds before it came to final stop. Speed brakes and thrust reversers were deployed normally and Positive deceleration is recorded by DFDR during the landing roll.

The landing weight of the aircraft was 27 ton. As per the Quick Reference Handbook of CRJ-700 aircraft for wet/contaminated runway, the actual landing distance required with full flaps is around 5000 feet. The total runway length available at Chakeri, Kanpur is 9000 ft. As per the statement of the ATC controller and the first officer the aircraft landed past the middle marker which is around 4500 ft from runway end, the remaining runway was not enough to stop the aircraft on the runway under the prevailing rainy conditions, as a result the aircraft exited the runway and entered into soft ground.
